## MARTIN BERRY HOUSE PRESERVATION PLAN

100% SUBMISSION

1 MARCH 2016

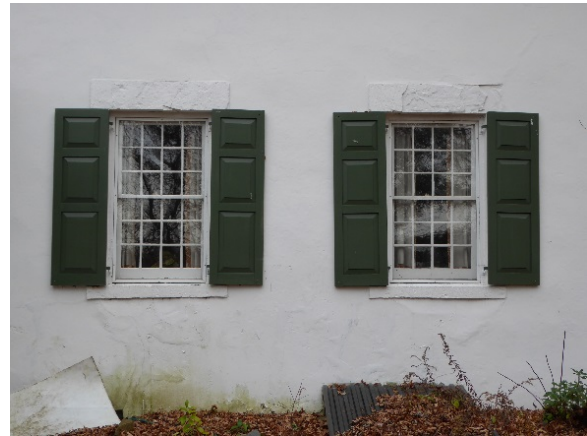
**Photo 17: Stone lintels at right two windows are scaling. Bulge and cracking in stucco visible below both windows.**

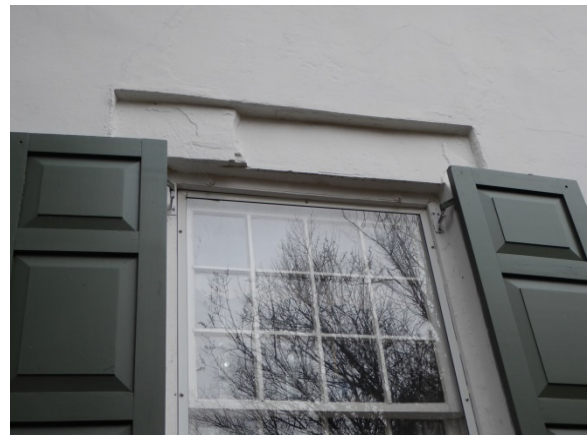
**Photo 18: Piece has broken off stone lintel at left first floor window.**

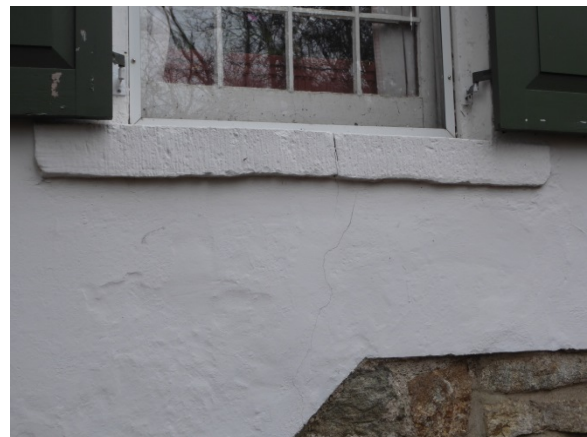
**Photo 19: Crack in sill and wall at left window.**

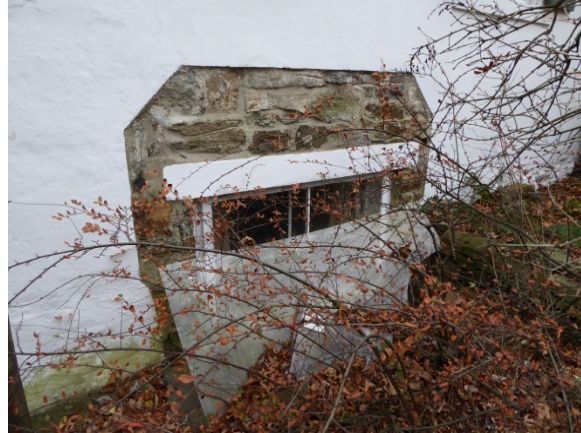
**Photo 20: Left basement window. It is unclear why there is no stucco on the wall surrounding the window. Biological growth on base of wall at left.**

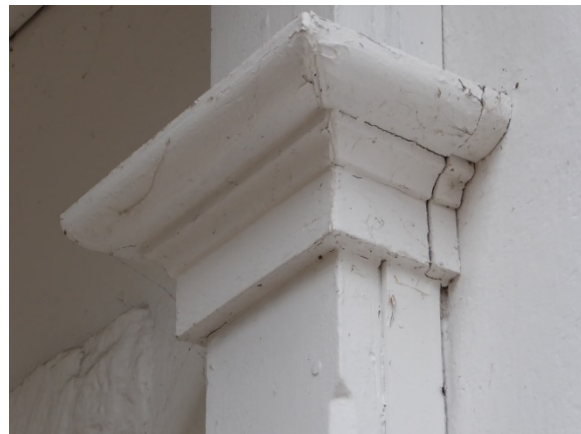
**Photo 22: Right pilaster of porch has replacement piece at wall.**

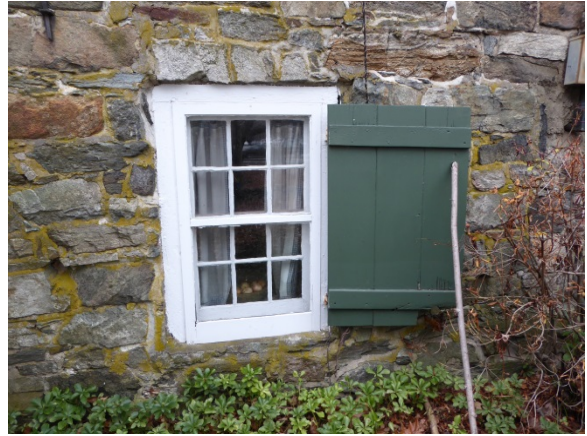
Photo 24: Basement window at main house. Bottom right piece of shutter missing. Biological growth at mortar joints. Iron tie rod visible at upper left.

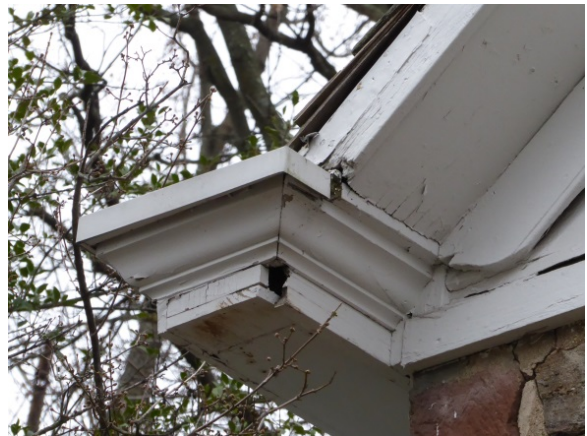
Photo 25: Left eave of gambrel roof at main house. Hole in corner of built-in gutter and rotted wood above cornice piece.

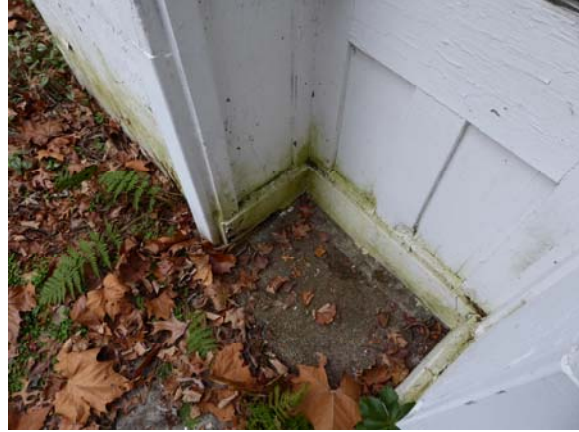
**Photo 26: Door into "smokehouse." Note considerable water damage at the door and trim..**

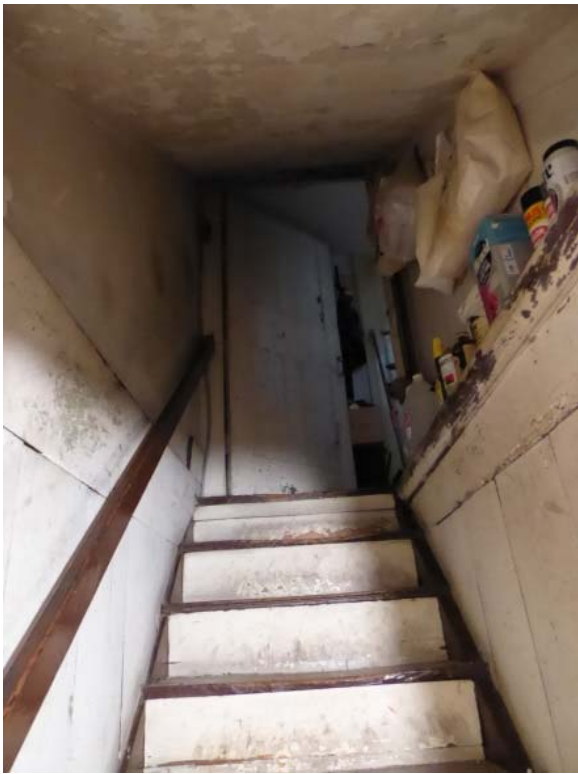
**Photo 3: Looking north up basement stairs. Plaster ceiling peeling and stairs worn.**

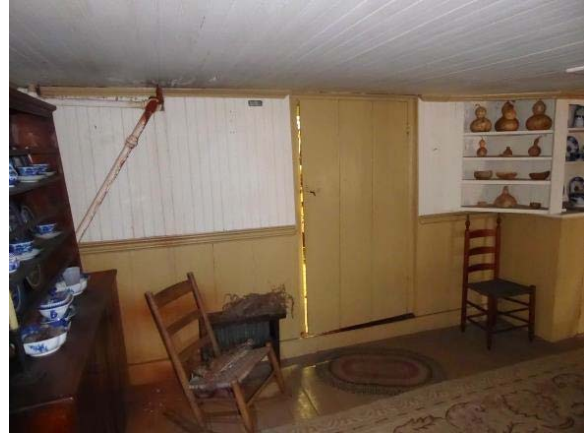
Photo 11: West wall with door to Open Cellar 002. Pipe at left is causing some water damage to wood.

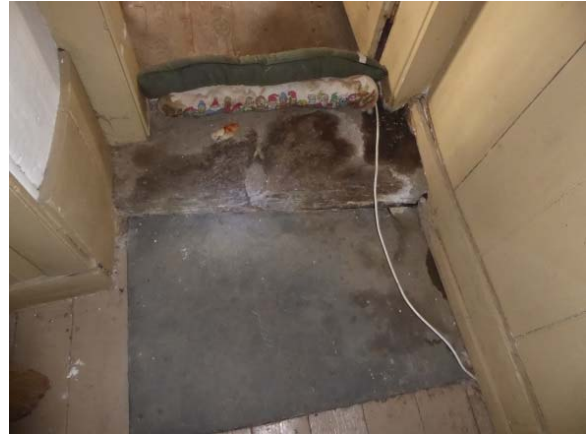
Photo 14: Stone slab and step up to smokehouse. Wood boards at side walls are bulging.

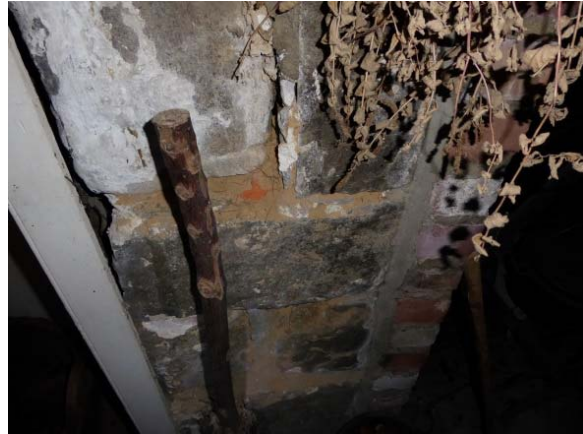
**Photo 16: Stone to left of fireplace has powdered remains of plaster.**

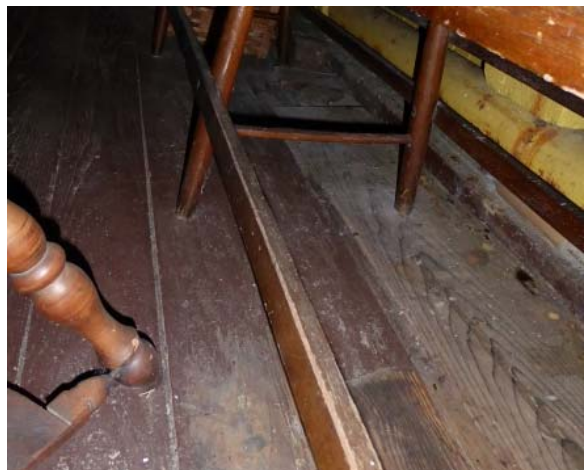
Photo 19: Flooring near north wall. Boards appear to have been replaced and are sagging down.

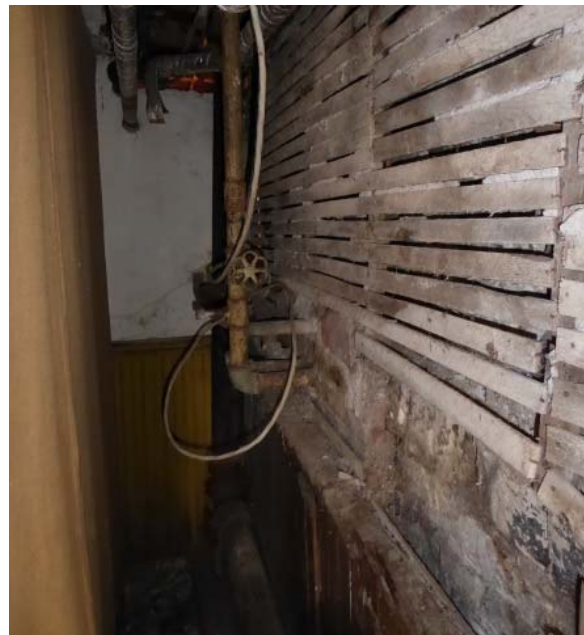
**Photo 21: Mechanical space at northwest corner. Flooring is rotted and plaster is gone. Wood wainscot is painted a different color from the rest of the room.**

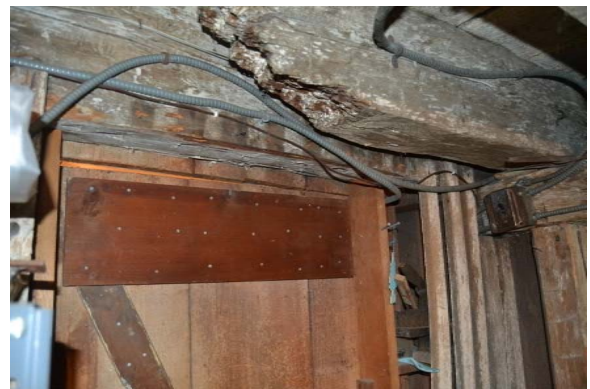
**Photo 28: View in the southeast corner. Note the ghost marks of the slats above the door. Also note the deteriorated end of the large joist that extends into the room from Room 002.**

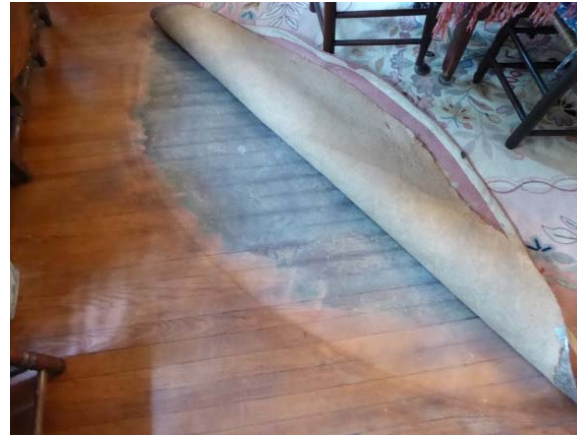
**Photo 43: Narrow floorboards not original. Finish is worn and boards are stained under rug.**

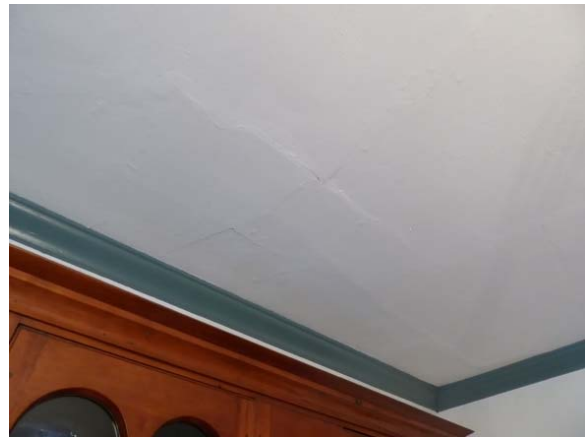
**Photo 44: Cracks in plaster ceiling near northwest corner.**

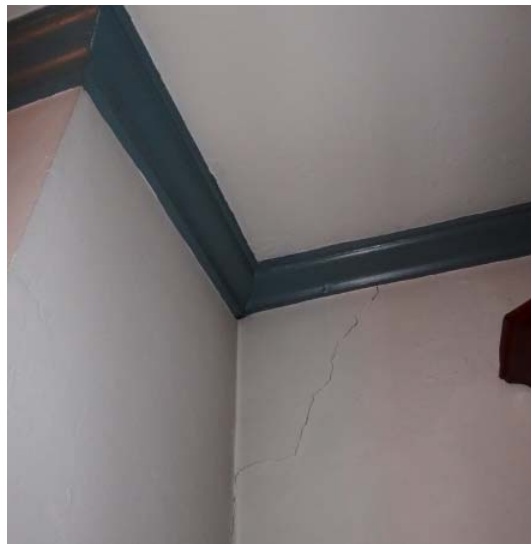
**Photo 45: Crack in east wall to right of fireplace.**

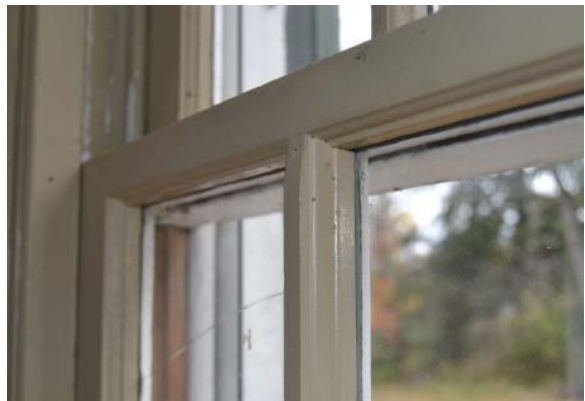
**Photo 61: Close-up of one of the north window sash showing the replacement muntin, which is deeper than the sash and wider than the original muntin. Also note the small hole where a brad secures the muntin in place.**

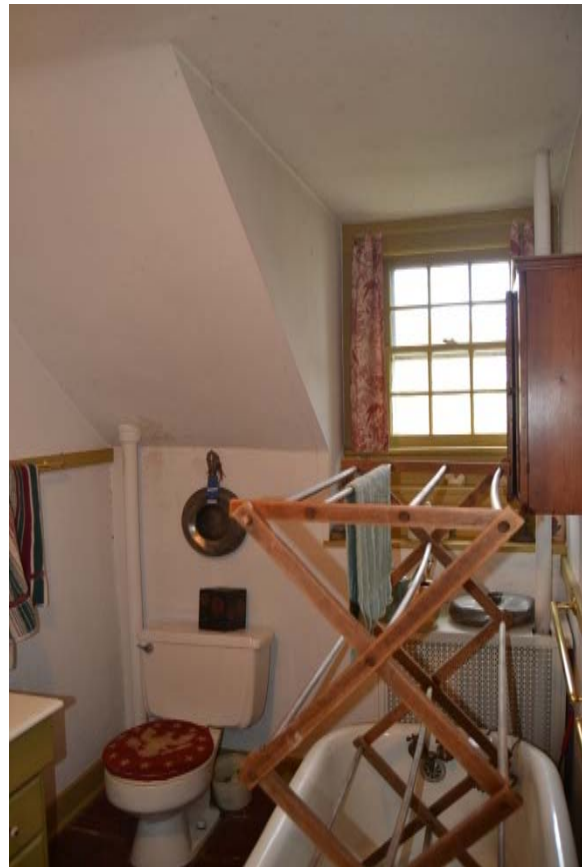
Photo 87: General view north. Note water damage at vent pipe next to toilet.

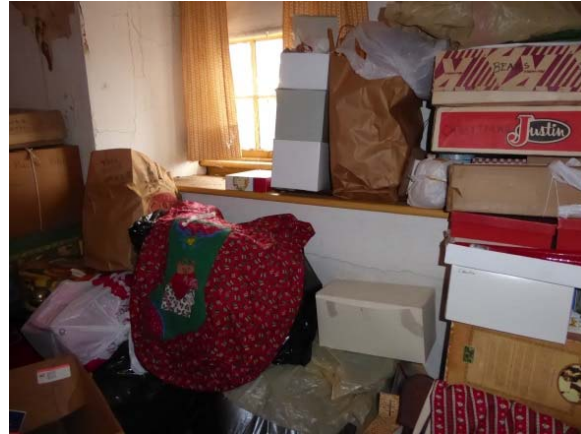
Photo 91: View west showing window and ledge. Crack runs length of wall below ledge.

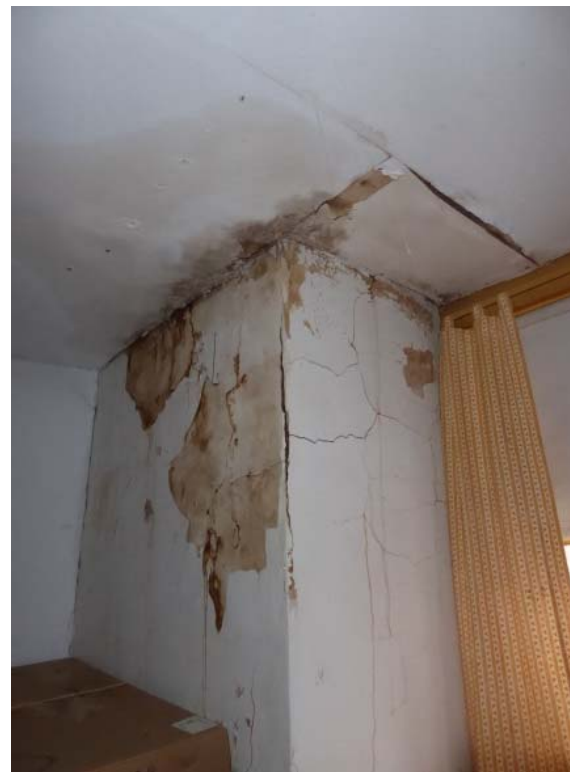
Photo 92: Plaster is failing at ceiling and walls of chimney bump-out.

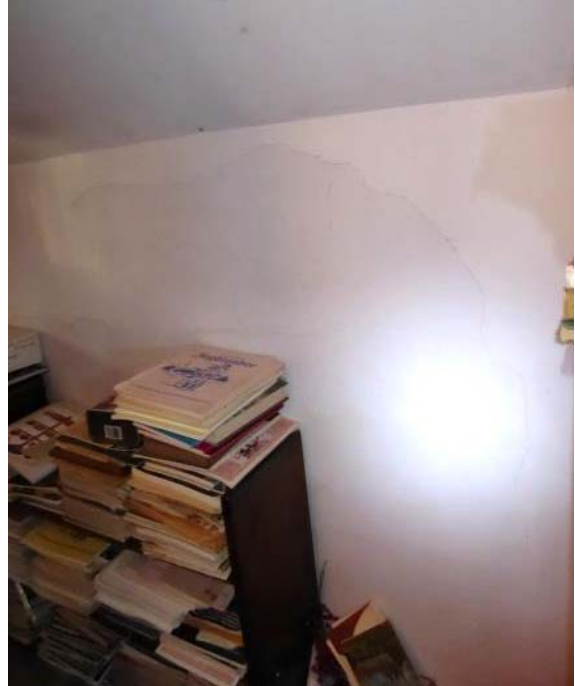
**Photo 93:** Looking towards north wall; cracks at wall and epoxy repair in sloped ceiling visible.

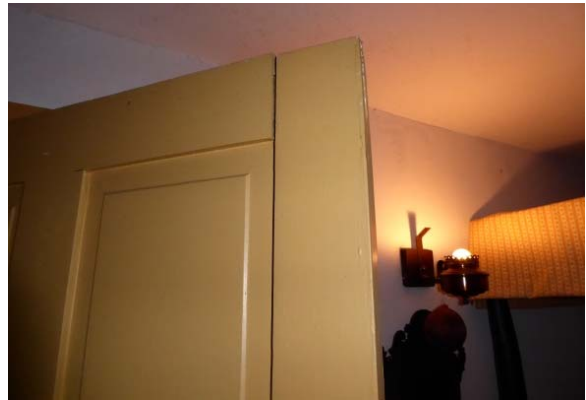
**Photo 94:** Door stile and rail are separating.

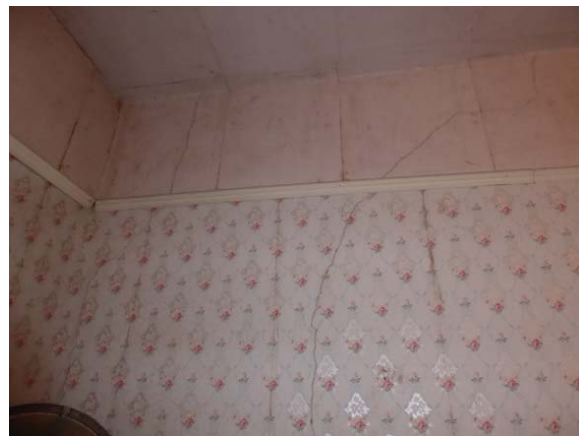
Photo 98: Cracks in wall at northwest corner.

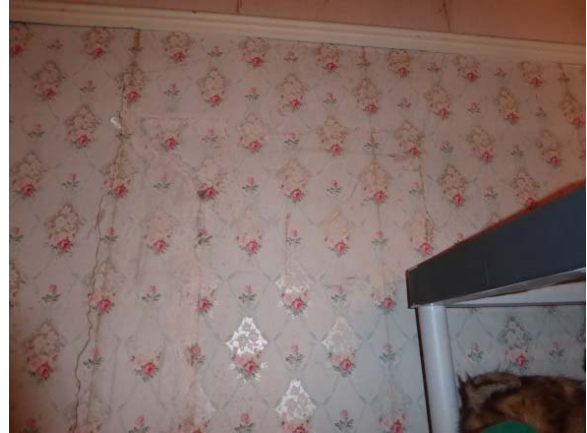
**Photo 99: Cracks in south wall at left and square-shaped crack behind shelf indicating some kind of panel behind the wallpaper.**

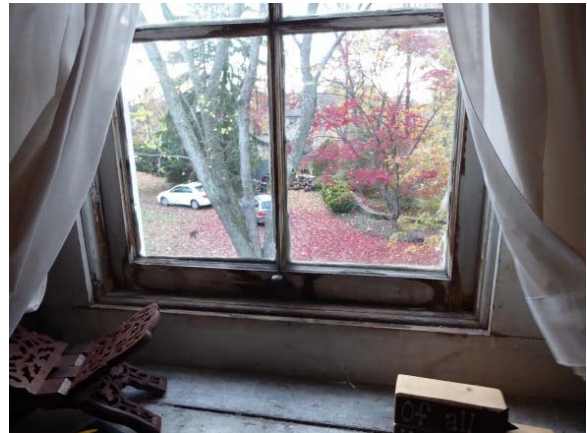
**Photo 100: Detail of window. Wood has water damage.**

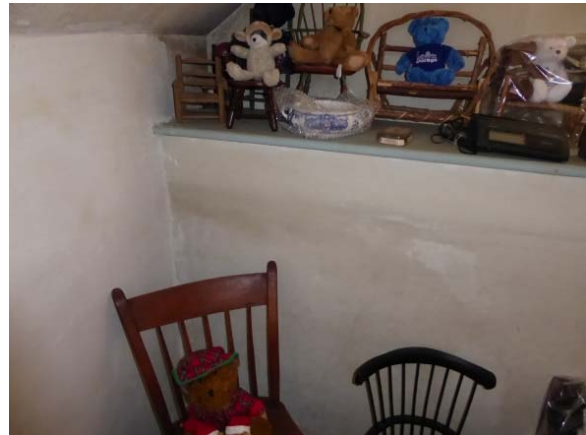
Photo 103: Plaster under ledge is uneven.

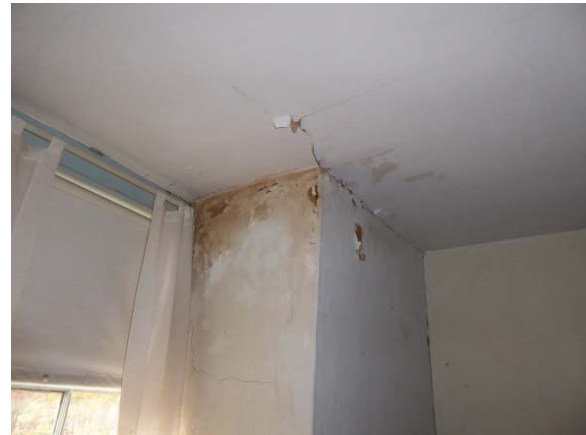
Photo 104: Plaster is failing at ceiling and walls of chimney bump-out.

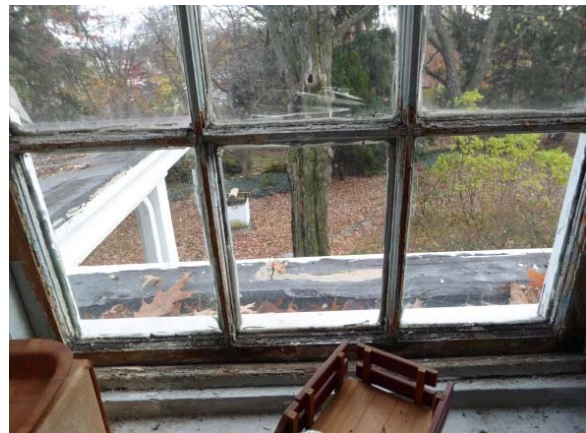
Photo 105: Detail of west window. Water damage to wood is visible.

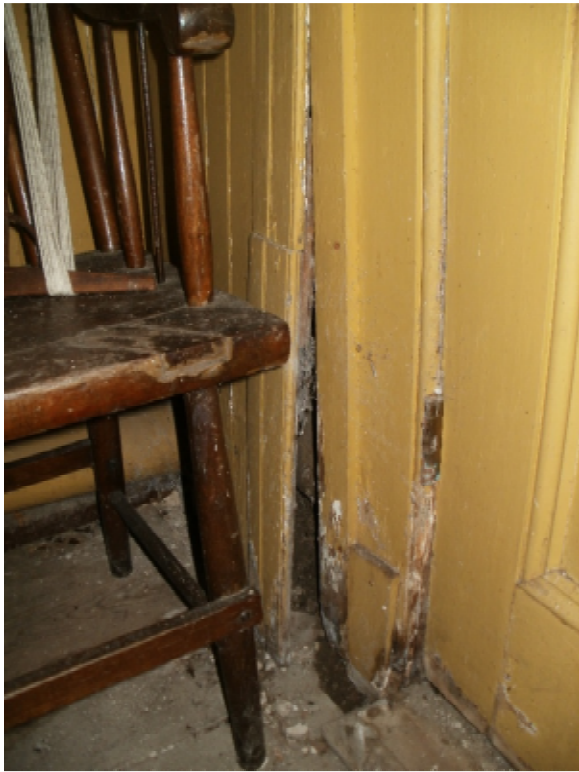
Northeast corner basement wall finishes displaced from water infiltration and wall debris

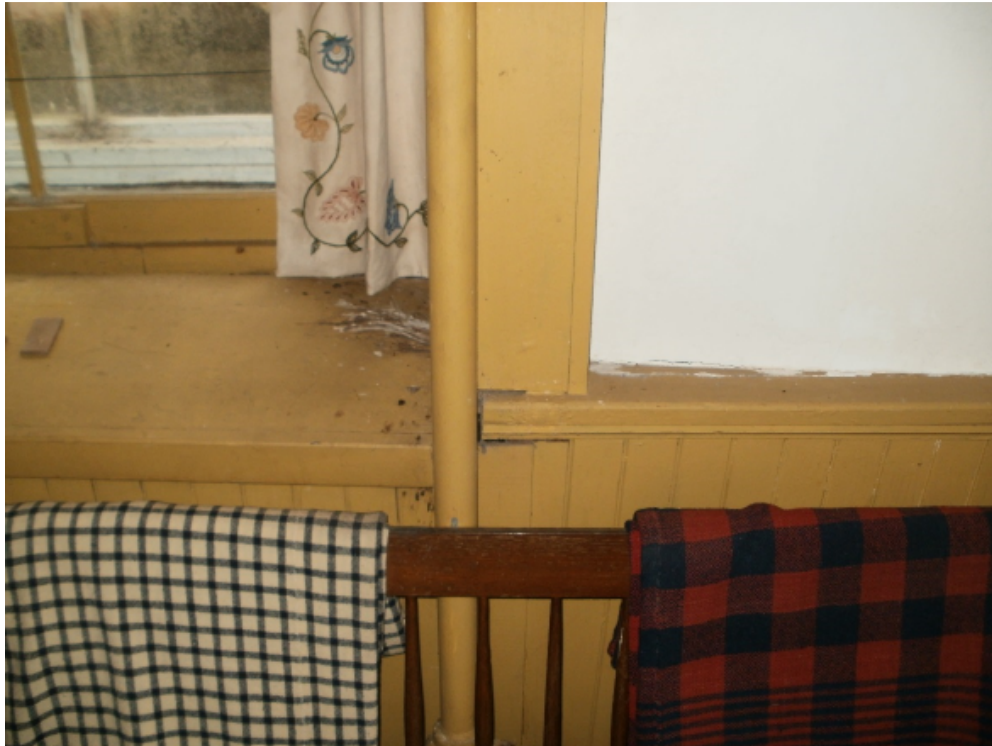
North basement wall finishes displaced from water infiltration and wall debris

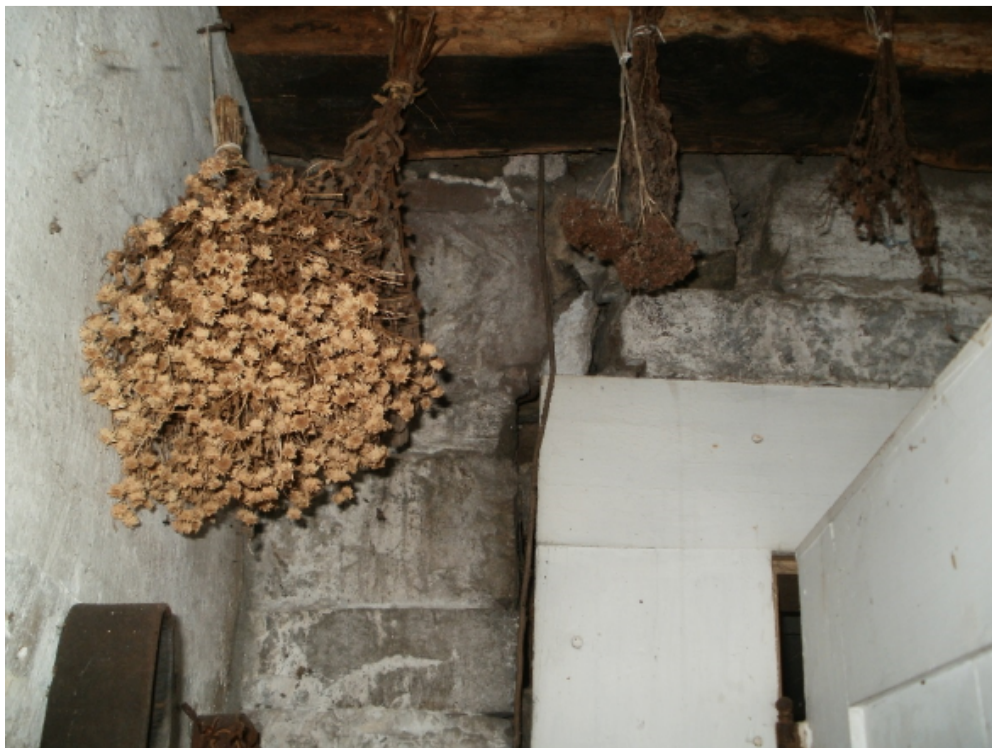
Missing mortar in stone wall above door from smokehouse

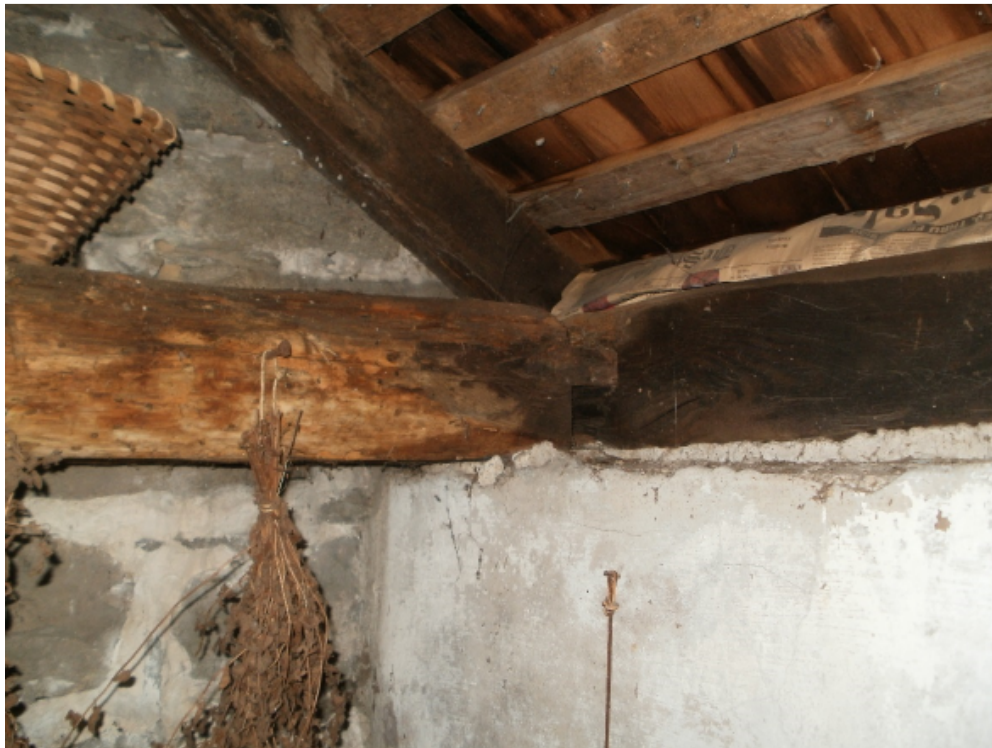
Separate mortise and tendon joint of smokehouse roof framing

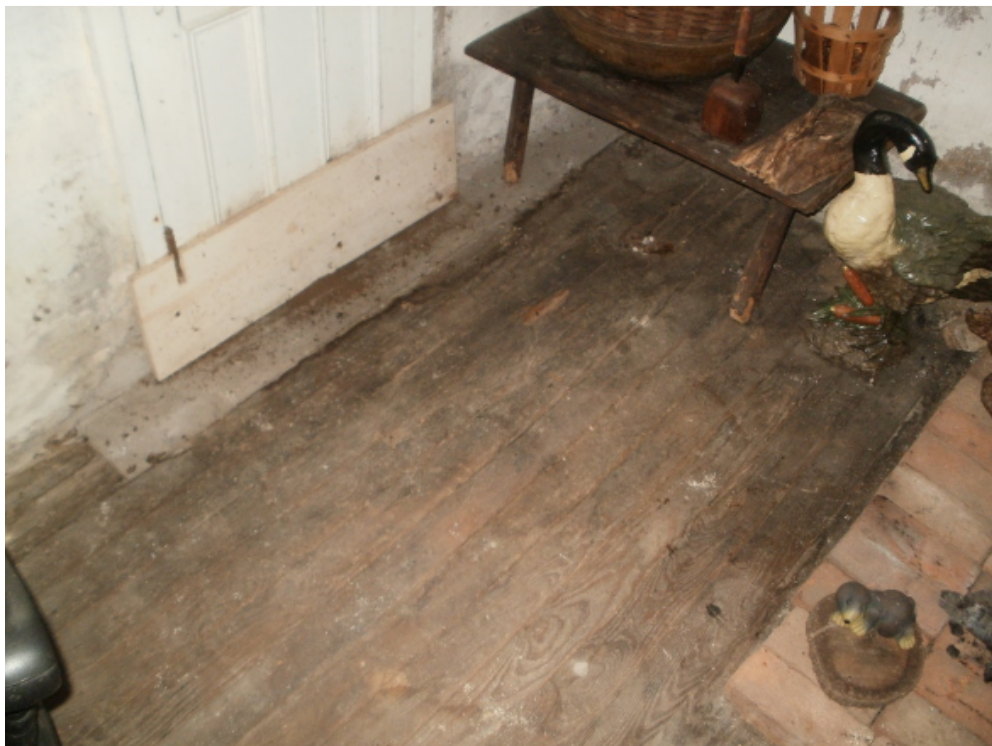
Water damage and buckled floor boards in smokehouse

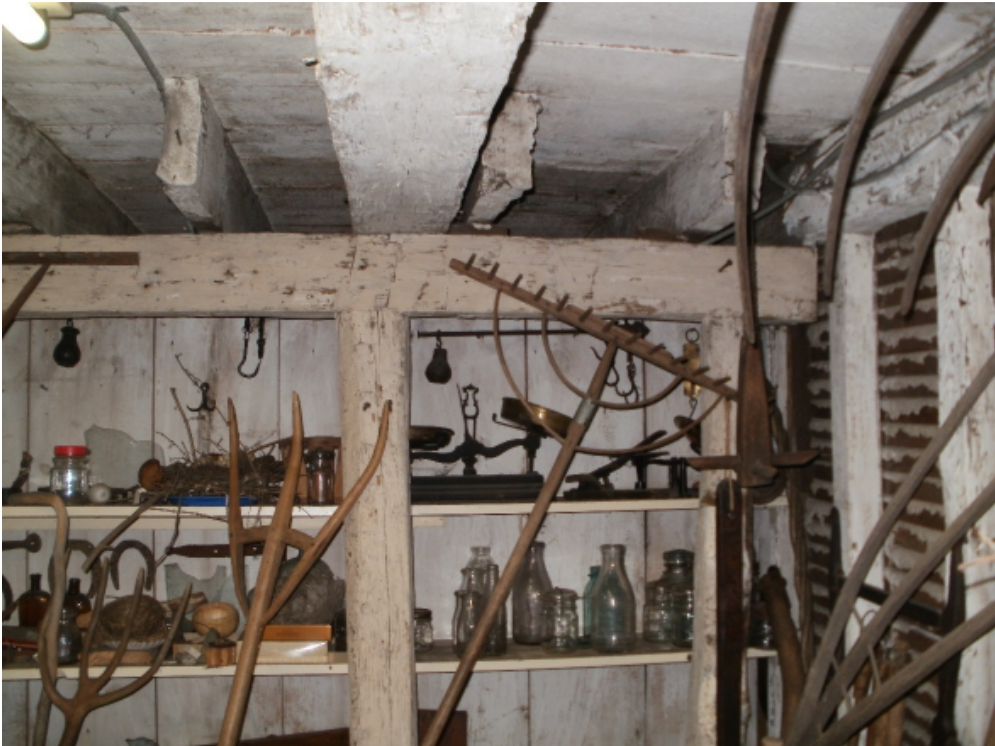
Varying floor joist depths and shims

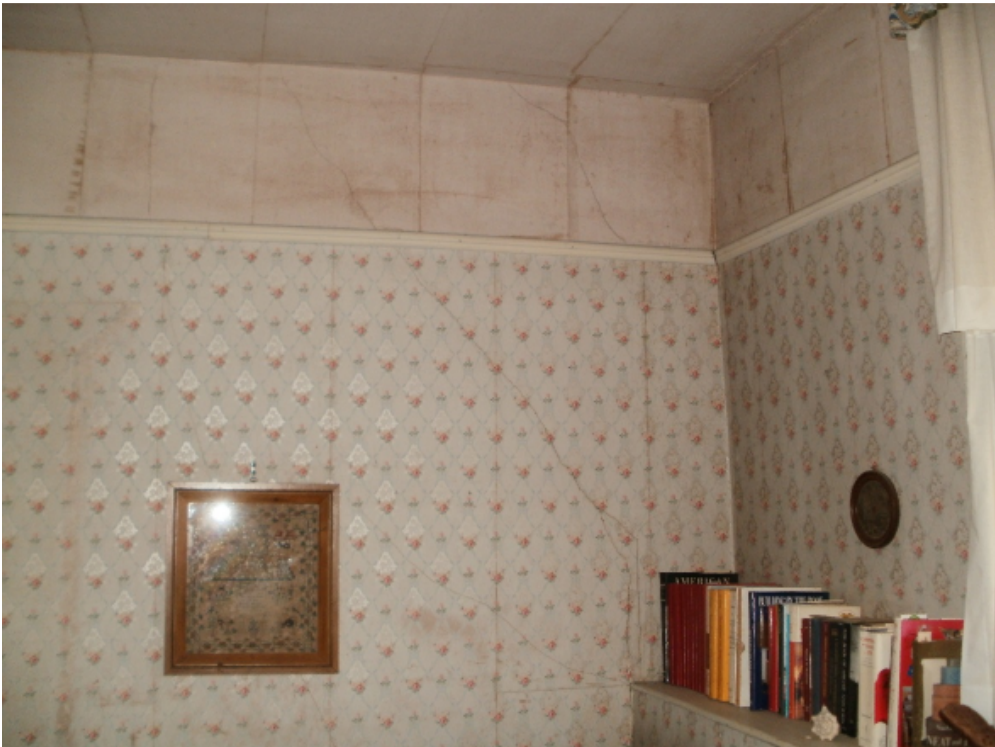
Typical cracks in plaster wall finishes

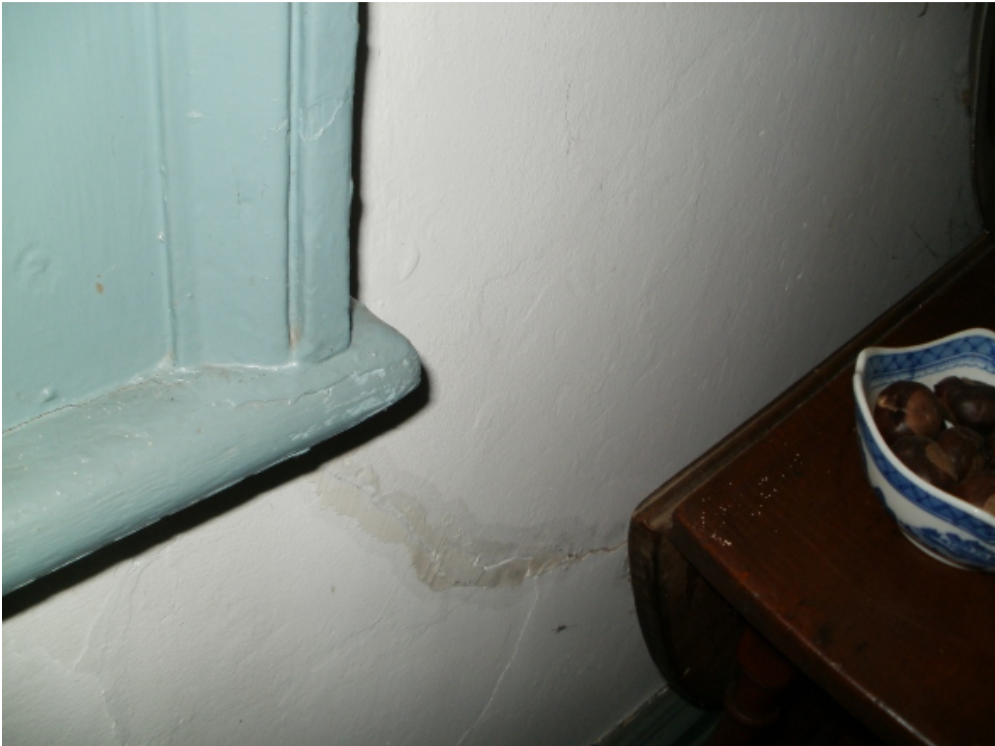
Typical cracks in plaster wall finishes

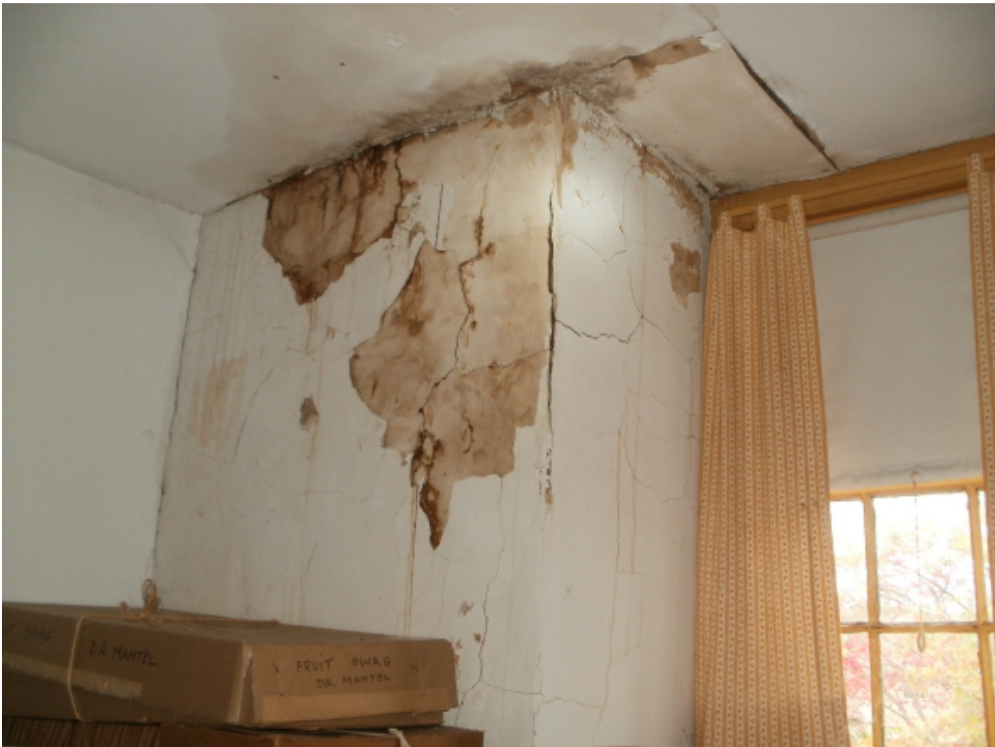
Water damage at west side north chimney

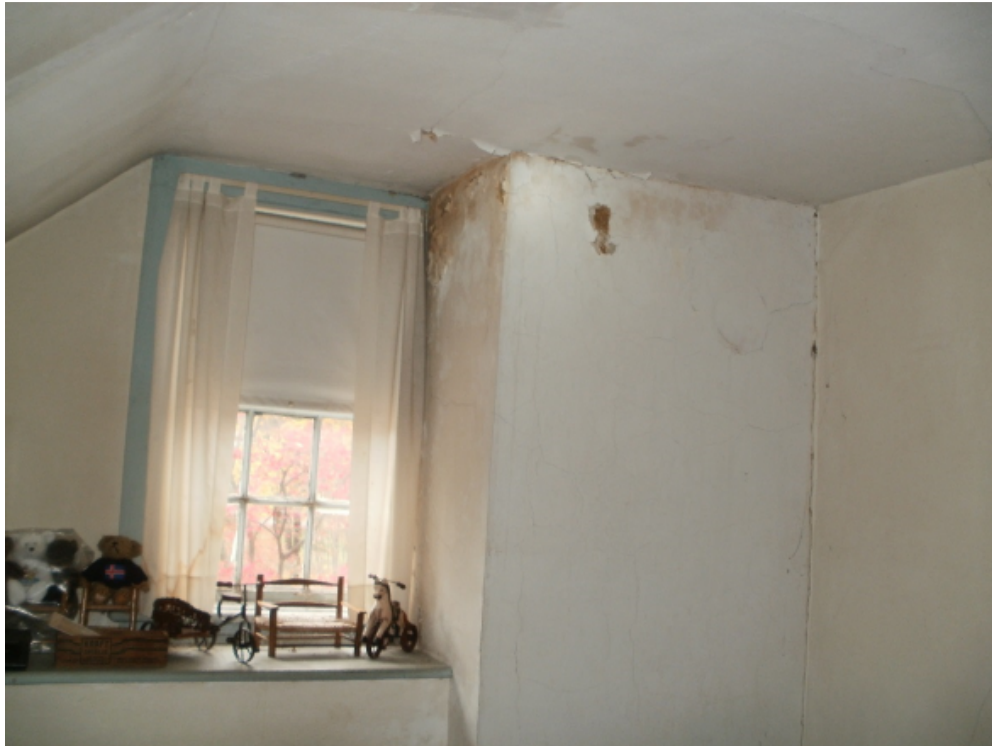
Water damage at west side south chimney

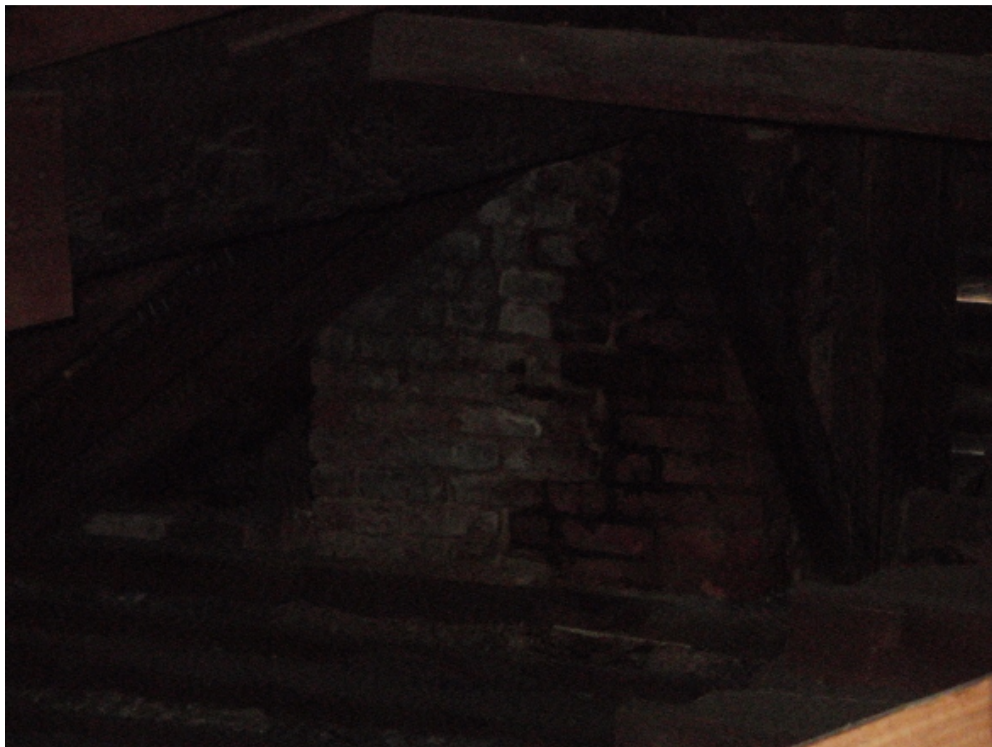
Water staining on west side south chimney inside attic

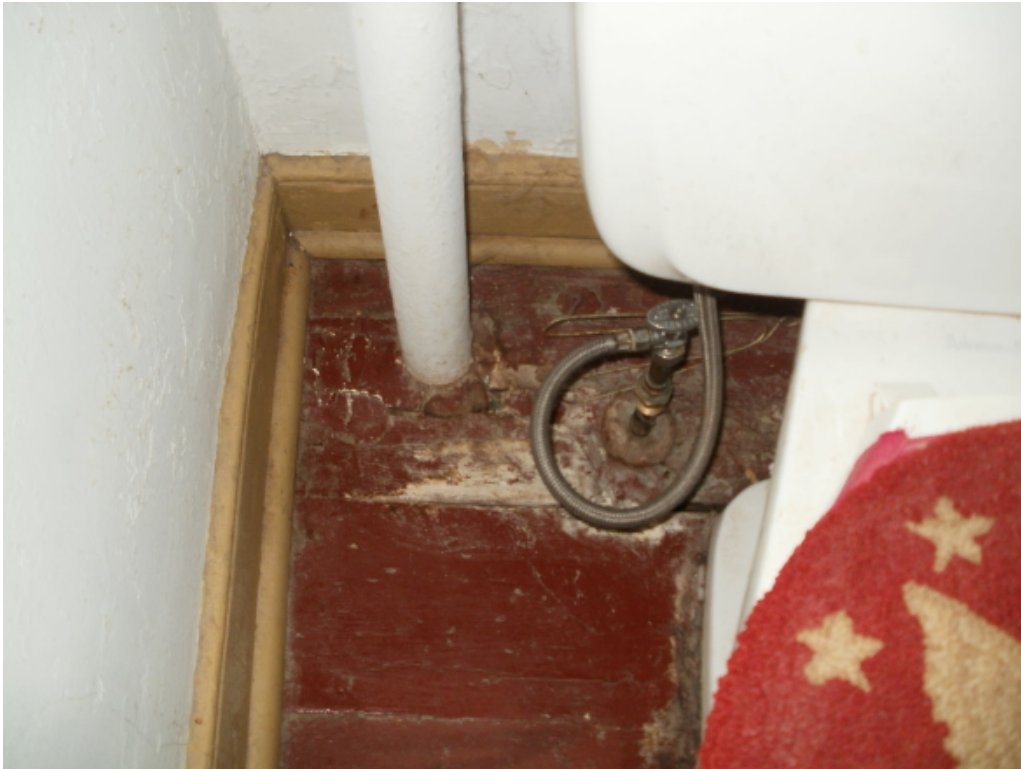
Water damage and failing floor in second floor bathroom

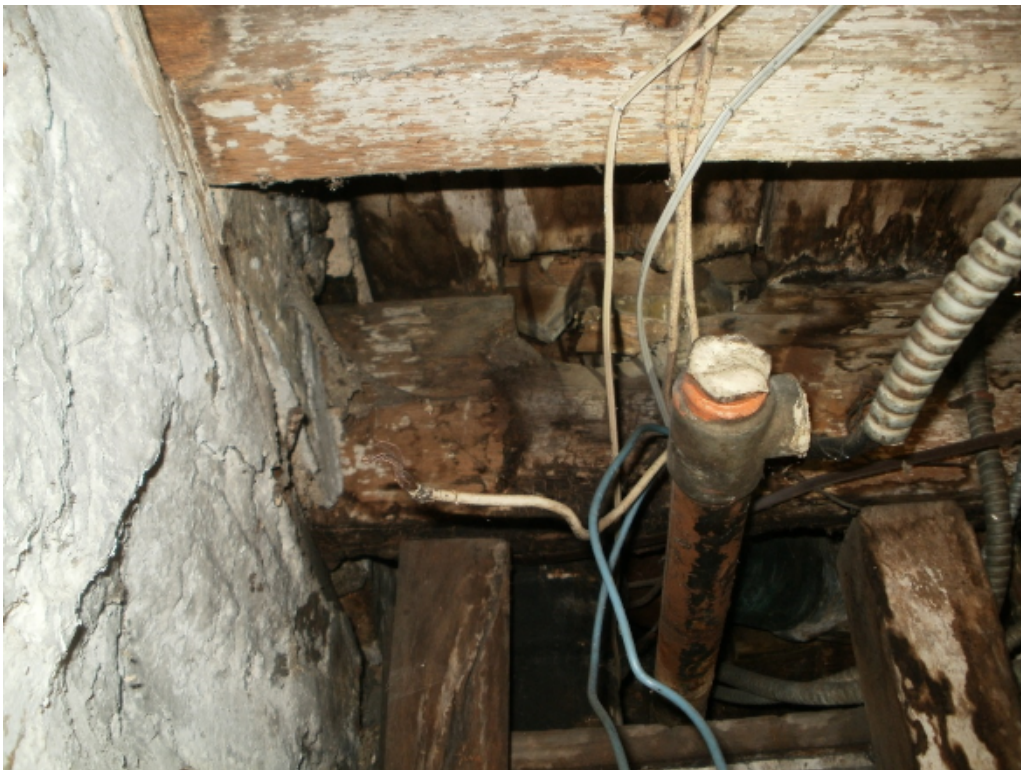
Water staining on first floor framing along north wall below second floor bathroom leak

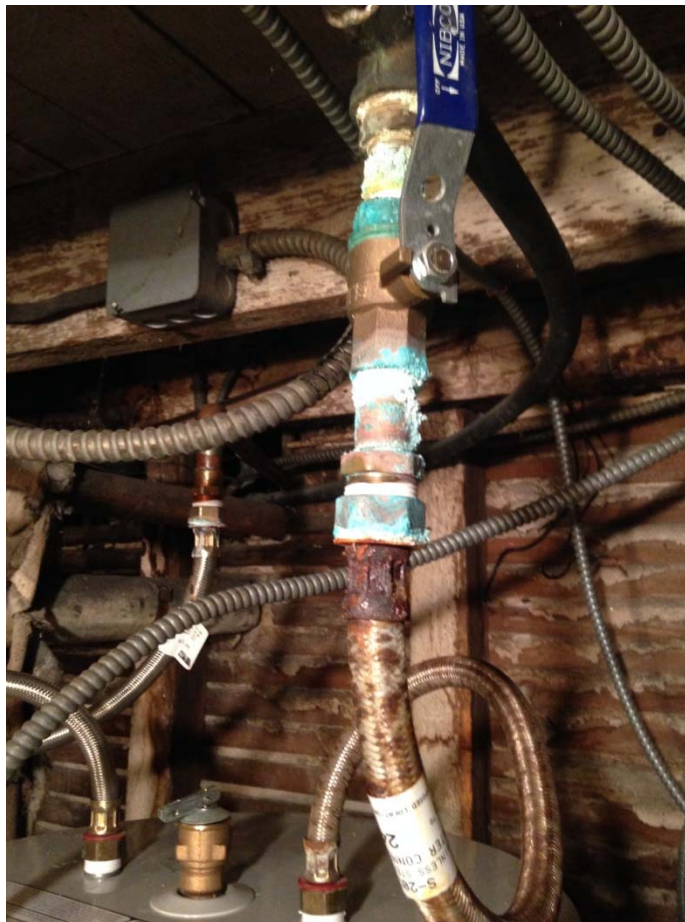
CORROSION AT WATER HEATER
