## MARTIN BERRY HOUSE PRESERVATION PLAN

100% SUBMISSION

1 MARCH 2016

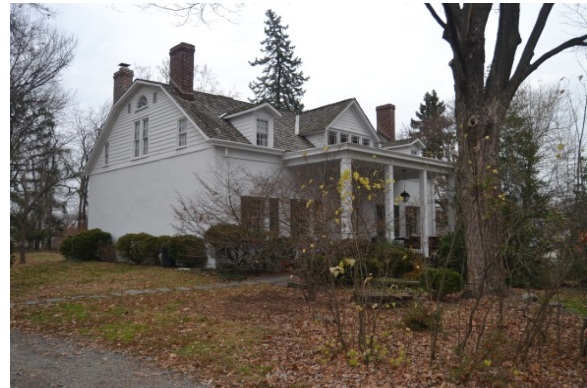
**Photo 1: Overall view of the south façade from the southwest.**

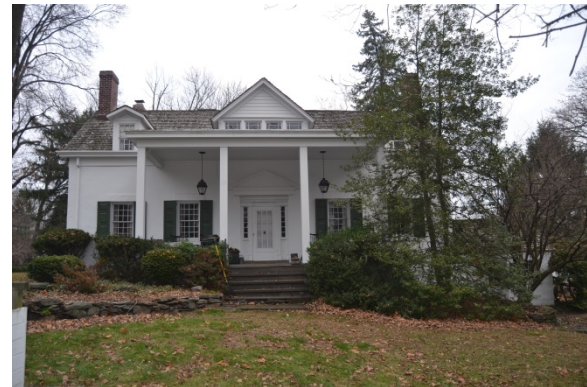
**Photo 2: Direct view of the south façade highlighting the large Colonial Revival porch.**

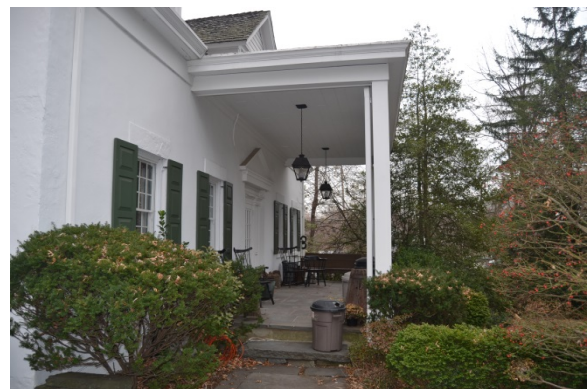
**Photo 3: View of the porch from the west.**

Condition: Generally good, although there are some sections of deteriorated crown moulding resulting from roofing and drainage failures.

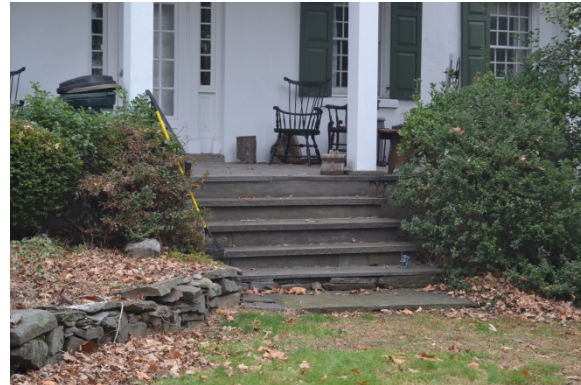
**Photo 4: Front steps leading up to the porch from the south.**

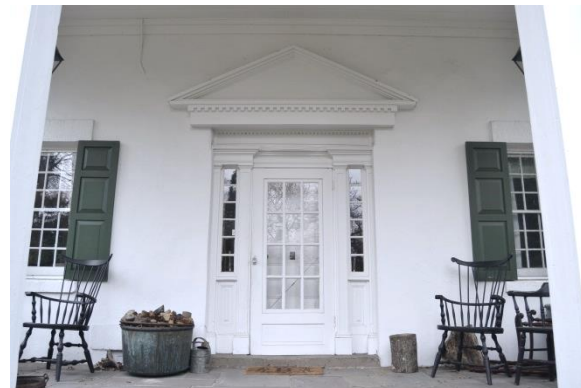
**Photo 5: View of the front entry door. The pediment above the door represents later construction by the current owner, installed after the former porch was removed.**

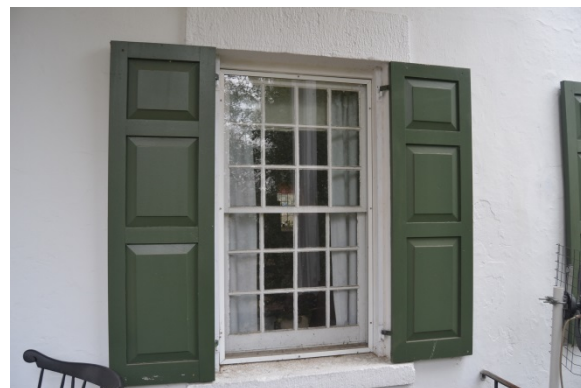
Condition: The windows at the main house are in good condition. The two-light basement sash is not appropriate, but in good condition. The six-light basement sash is in poor condition. The fixed sash at the smokehouse is in fair condition.

**Photo 6: Typical first floor window at the main section of the house.**

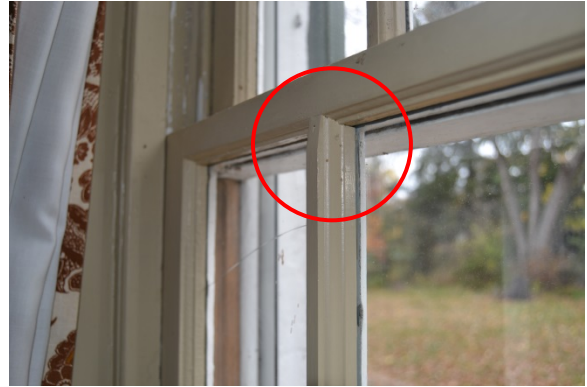
**Photo 7: Detail of window interior. The thickness of the muntin, the taper where it meets the rail and the small nail hole all indicate that the muntin is a replacement.**

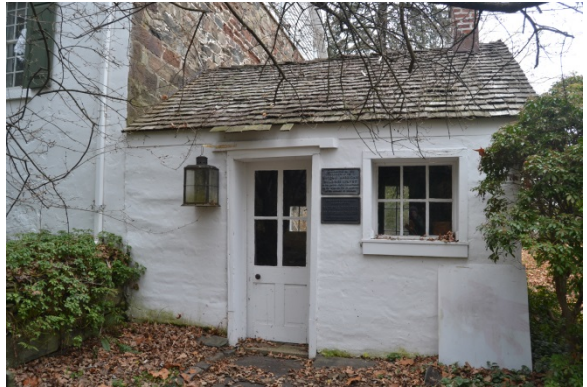
**Photo 8: View of the south elevation of the "smokehouse."**

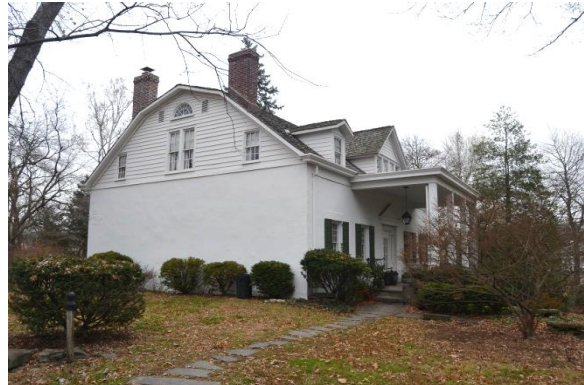
Photo 9: General view from the west.

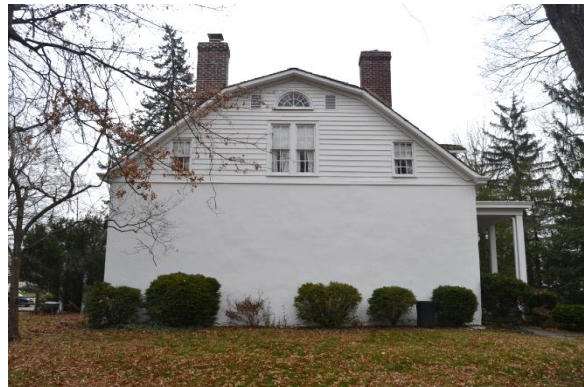
Condition: The chimneys are in good condition with the exception that the north chimney has been repointed with

Photo 10: General view of the west elevation.

inappropriate Portland cement based

mortar and some of the brick in the

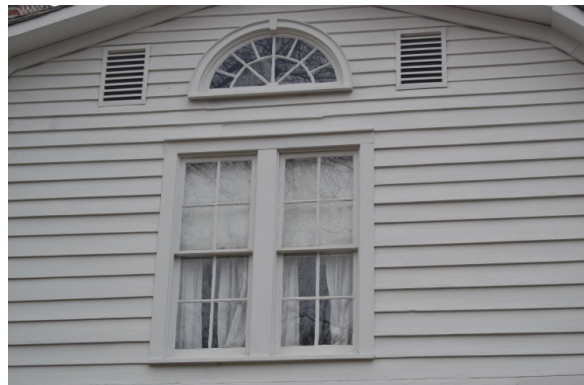
Photo 11: View of the arched fanlight at the attic and the paired four-over-four windows at the second floor.

Condition: Good.

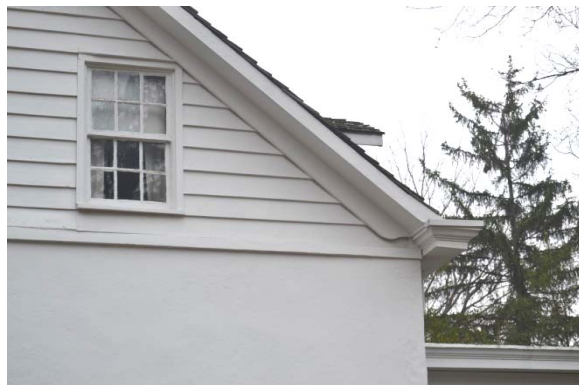
**Photo 12: View of the south gambrel end roof slope and window.**

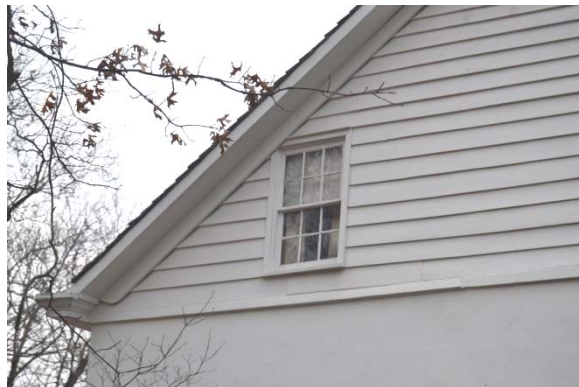
**Photo 13: View of the north gambrel end roof slope and window.**

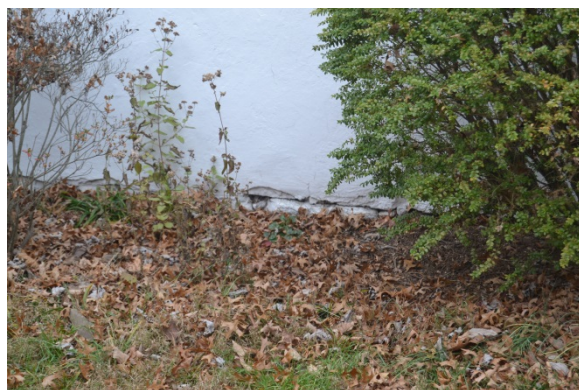
**Photo 14: Area of exposed stone foundation at the base of the stucco on the west elevation.**

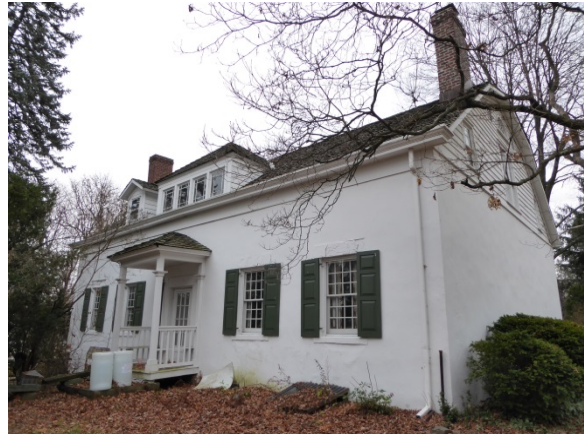
**Photo 15: General view of the north elevation.**

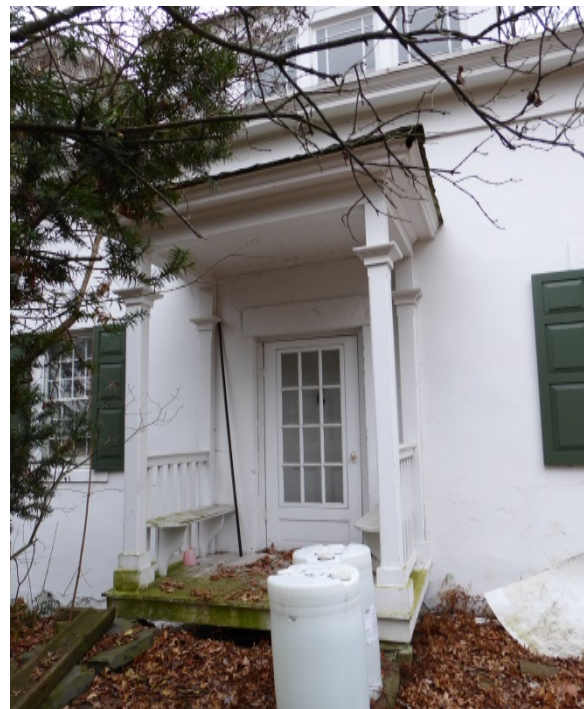
**Photo 16: View of the rear entry porch and storm door. Biological growth on porch floorboards.**

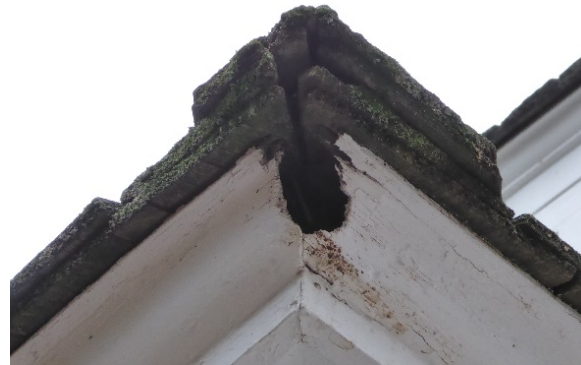
Condition: Good to fair. There is a hole in the right corner of the eave. The wood roof shingles have heavy biological growth. There is also biological growth on the floorboards, left rail, and column bases. The column bases have an additional box-out which does not appear on HABS or the National Register documentation. The porch appears in HABS documentation as "modern." The benches appear in the 1973 National Register Nomination but are probably not original to the construction of the porch. The capital of the right pilaster has a replacement piece at the wall.

**Photo 21: Hole in eave at right corner of porch roof.**

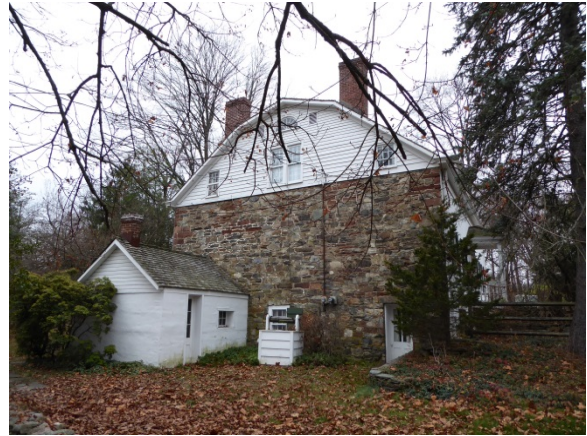
Photo 23: Overall view of east elevation.

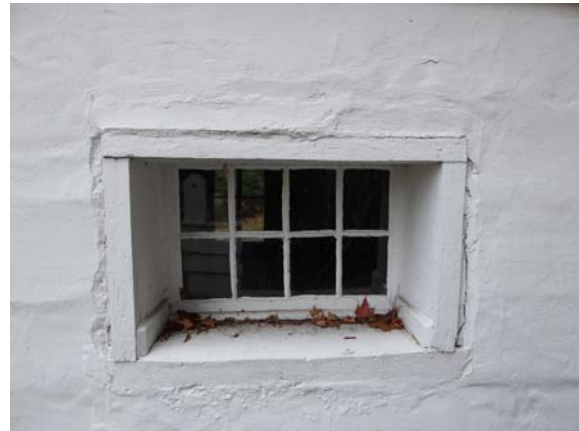
**Photo 27: Eight-lite fixed window at north elevation of "smokehouse."**

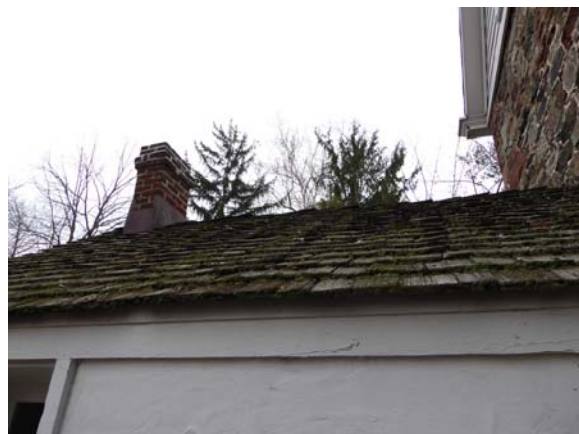
Condition: Fair to poor. There is heavy biological growth on the north side of the gable roof.

**Photo 28: View of "smokehouse" roof. Shingles exhibit extensive biological growth and cupping.**

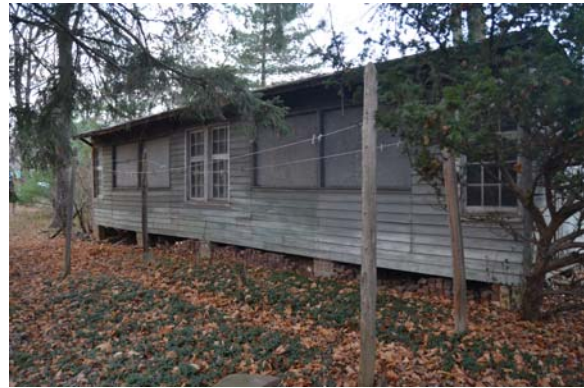
Photo 31: Overall view of the chicken coop from the southeast.

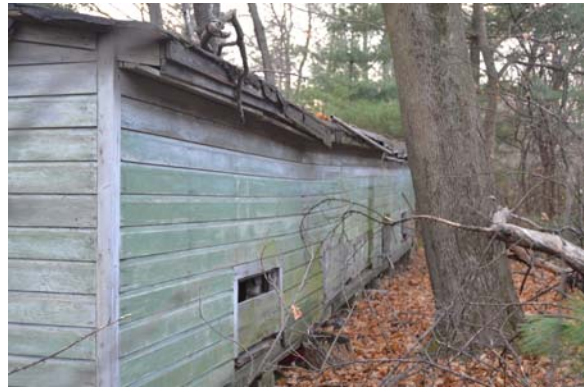
Photo 29: View of the north elevation of the chicken coop.

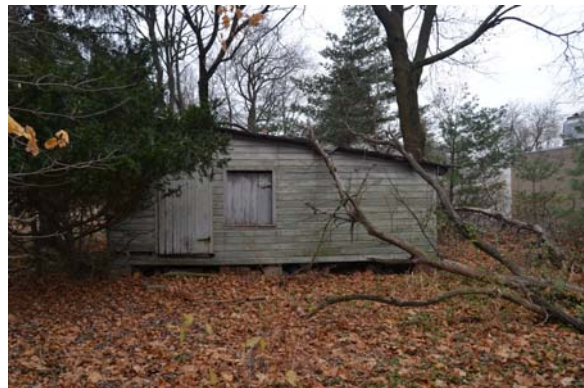
Photo 30: View of east elevation.

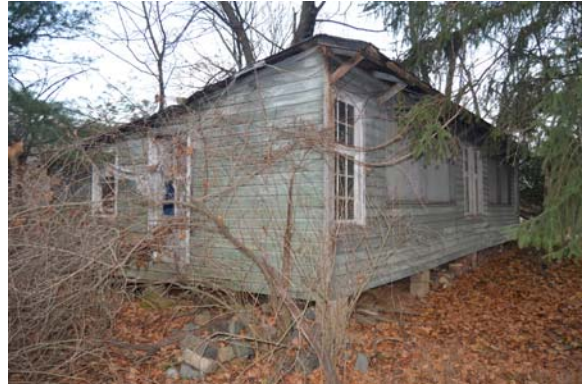
Photo 32: West elevation.

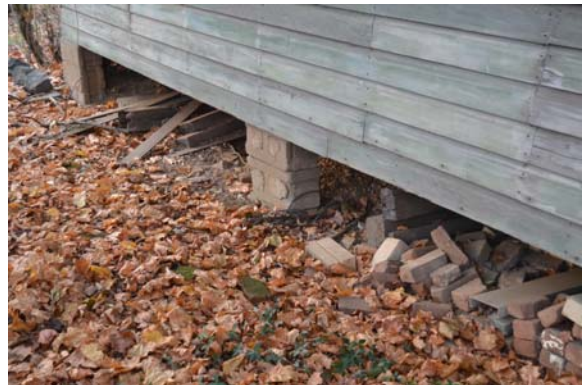
Condition: Fair, although the condition of the piers would not meet current construction standards.

Photo 33: Detail of concrete block foundation piers..

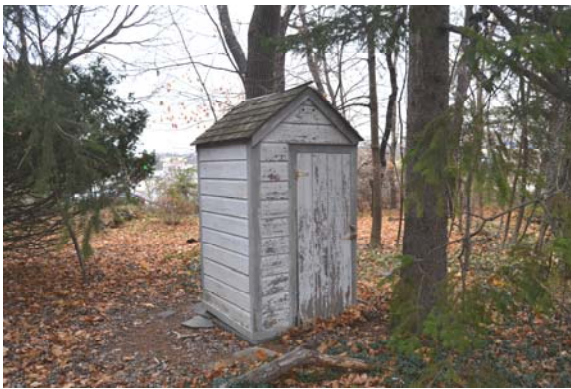
Condition: It is generally in good condition with prep and painting required.

Photo 35: View of the privy.

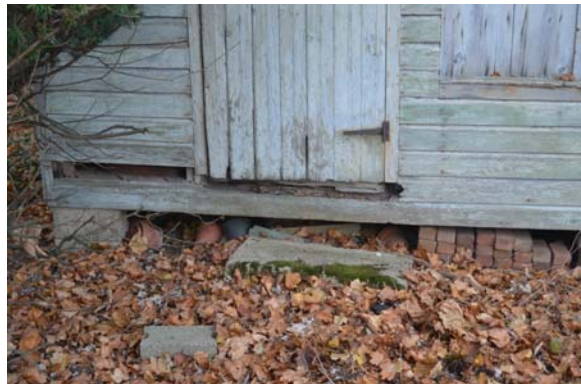
Condition: Both doors are in poor condition.

Photo 34: Close-up of the bottom of the east board-and-batten door.

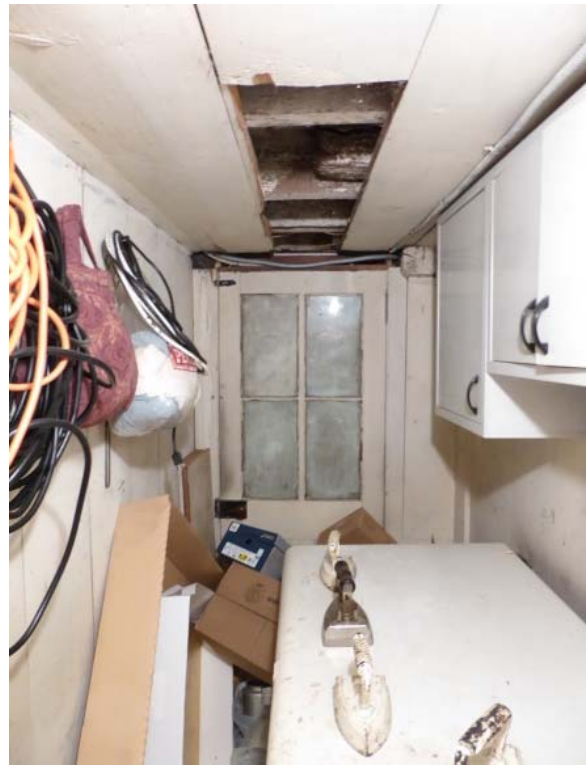
**Photo 1: Looking east towards door to Museum Bedroom. A missing board in the ceiling reveals the continuation of the large timber joists above this space.**

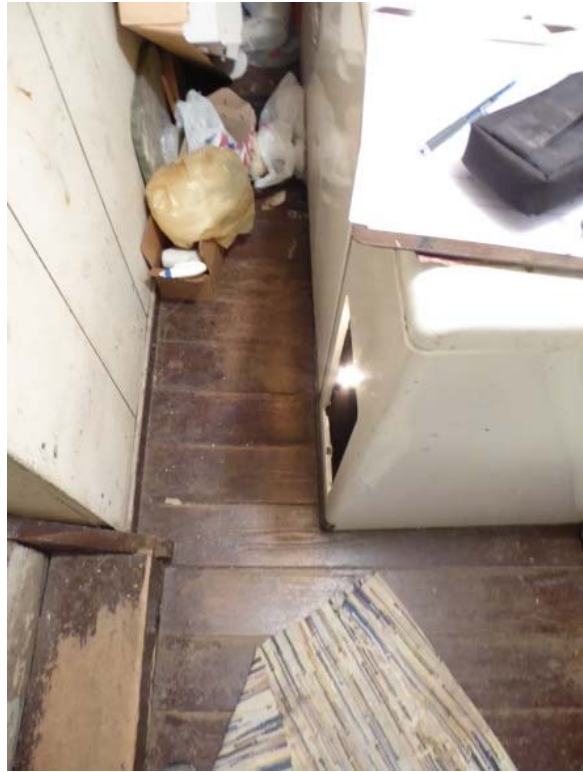
**Photo 4: Flooring near bottom of stairs. Chest freezer at top right.**

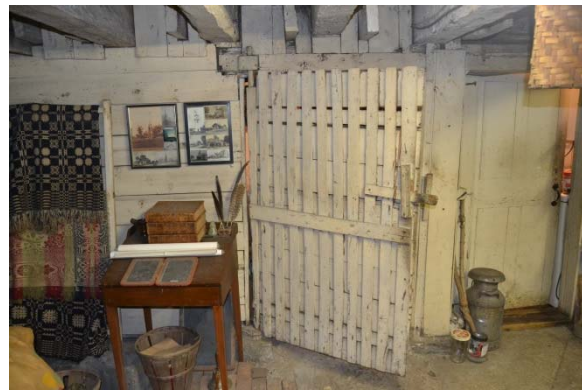
**Photo 9: The slatted door to Room 001 is of very early construction.**

Condition: The doors are generally in fair or good condition. They all need minor adjustment to operate properly. The slat door at the north should be removed and restored to remove the later boards and reverse or arrest the sag in the door using concealed methods.

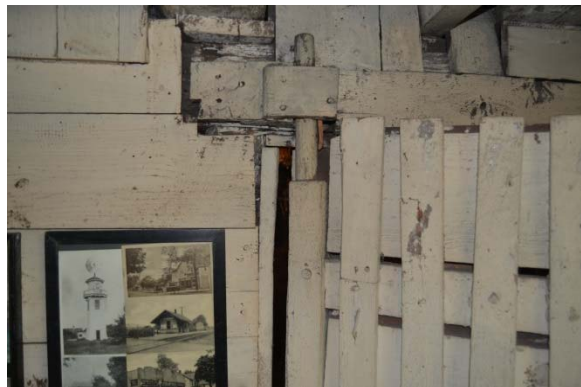
**Photo 10: Close-up of the upper hinge at the slatted door. A block has been nailed over the female portion of the hinge to repair it. The rounded portion of the stile can slide up so the bottom can lift out to remove the door.**

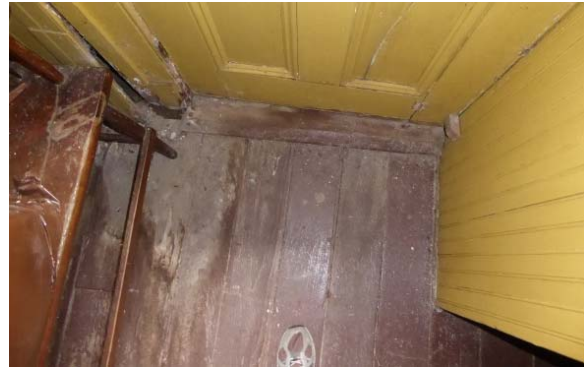
**Photo 20: Staining and rotted wood at floorboards and exterior door frame. Cracked wood door panel.**

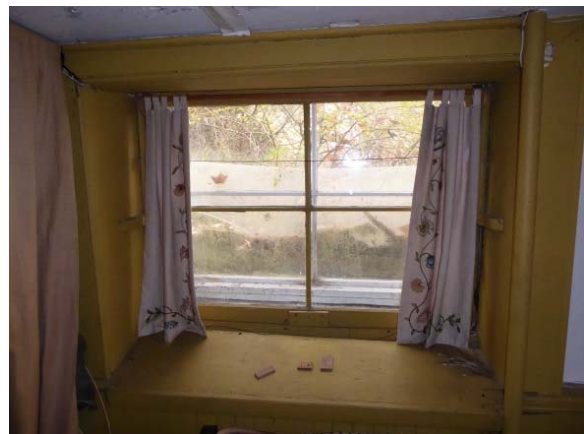
**Photo 22: Window at north wall. Ledge is buckling and wood at right side is rotted.**

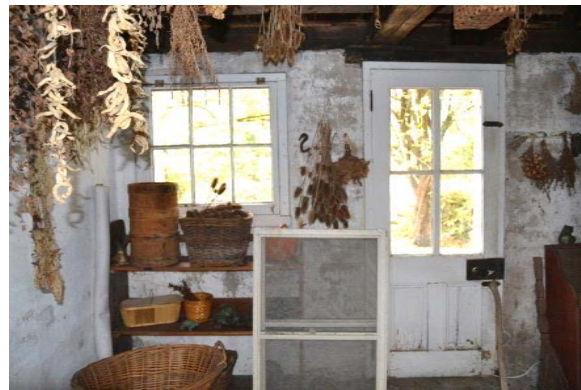
**Photo 30: View south showing the door and window on this side. The door is in poor condition.**

Condition: Both doors are in poor condition requiring extensive work at the panels, bottom rail and lower portions of the stiles.

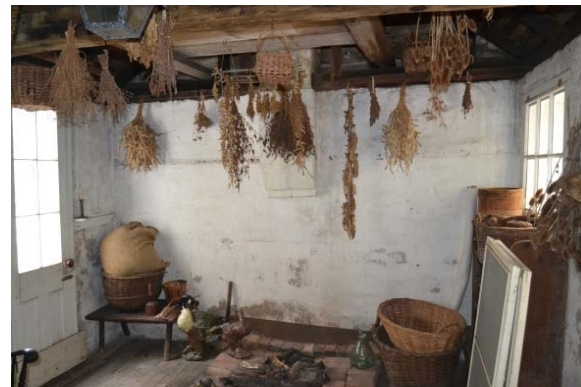
**Photo 31: View east in Room 006. Note the chimney base corbelled out from the wall, rather than extending down to a foundation at the floor.**

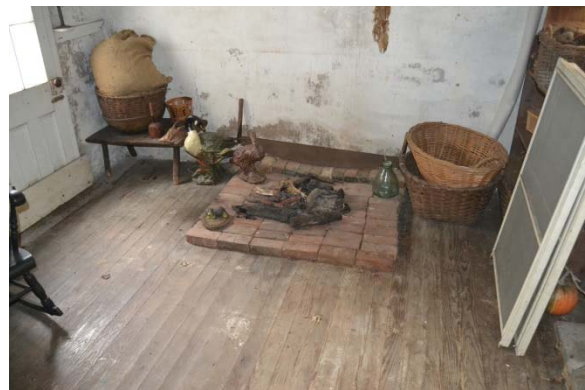
**Photo 33:** View of the floor showing a brick hearth, which along with the open fire remnants appear to be a later staging. At the right and left (south and north) the floor is very soft.

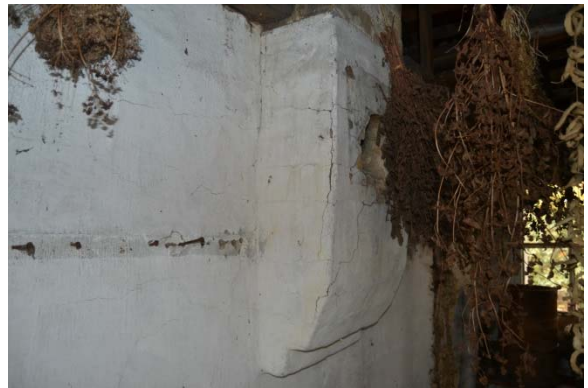
**Photo 34:** Close-up of the corbelled chimney base. Note thimble for a stove pipe.

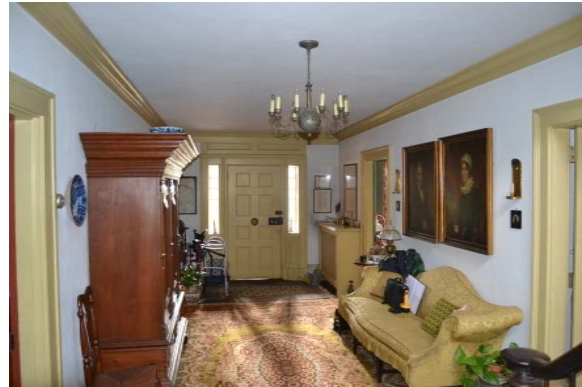
Photo 35: View south in Room 101.

Condition: Generally good with approximately 25 l.f. of cracking and 20 s.f. of flaking paint and or finish plaster coat.

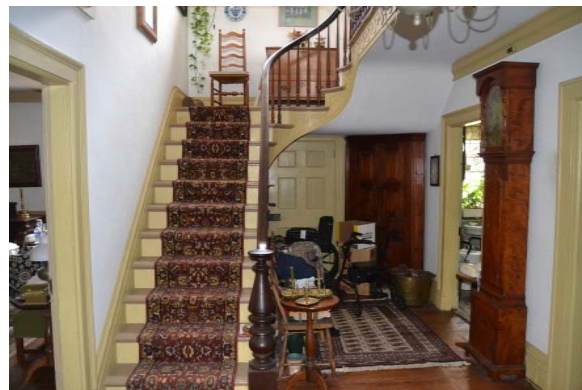
Photo 36: View north showing stairs. The rear entrance is visible below the landing.

**Condition:** The stairs and railing are generally solid and in good condition.

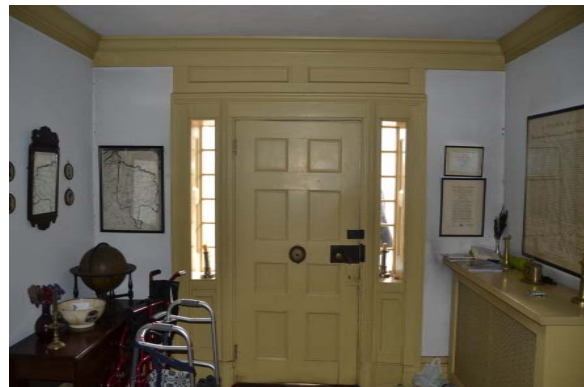
**Condition:** The front door is in fair condition. Although there is no sign of deterioration, there is evidence that some of the joints between the stiles and rails are loose. The sidelights are in good condition, with a fixed storm panel at the exterior.

Photo 39: The front entry door and sidelights.

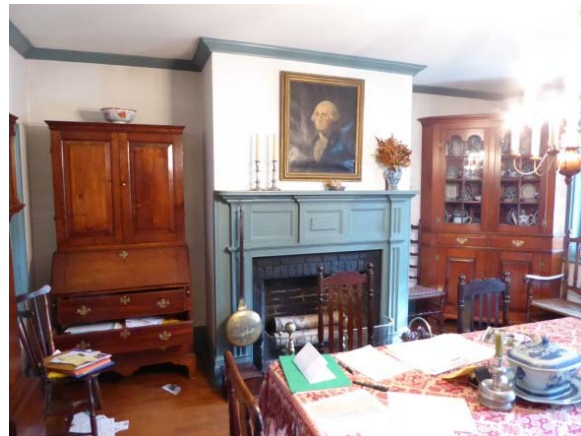
Photo 41: View east showing the fireplace.

Condition: Woodwork - good. Brick - fair. Some mortar is loose at the hearth and back of the fireplace. The chimney flue has been filled with insulation.

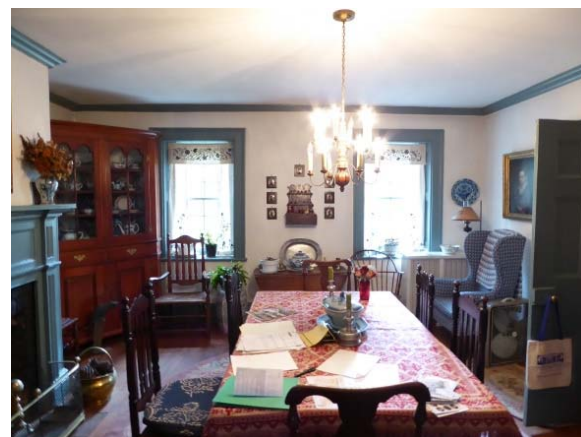
Photo 42: View of south wall in Room 102 showing windows.

Condition: Good to fair. Both windows operate although there are no sash cords or sash locks.

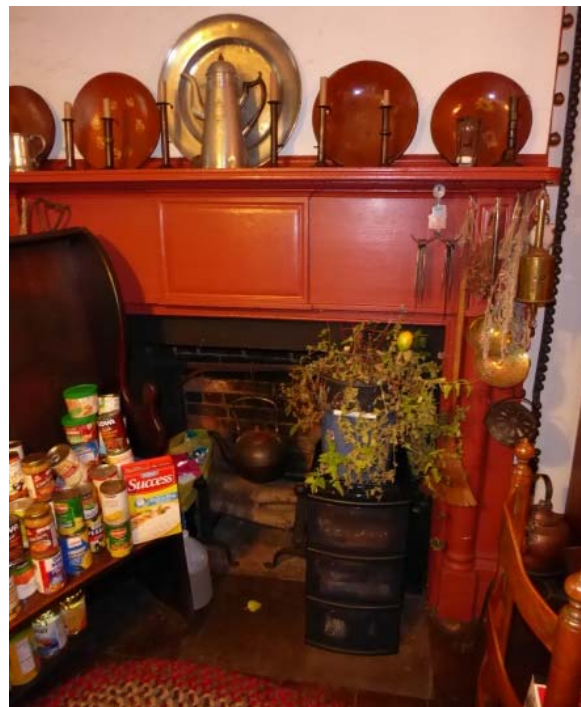
Photo 47: Fireplace at east wall.

Condition: Fair. There is a crack in the left wood panel of the surround. Pointing is missing in the hearth bricks. The stone hearth is sinking in the front. The chimney flue has been filled with insulation.

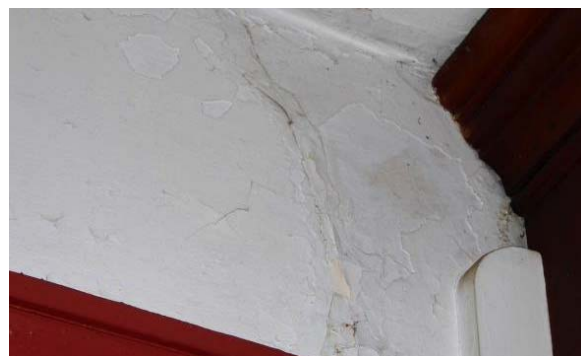
Photo 48: Crack in plaster above window at north wall.

Condition: Fair - there are many fine cracks in the plaster and a larger one above the fireplace. Plaster tape is visible.

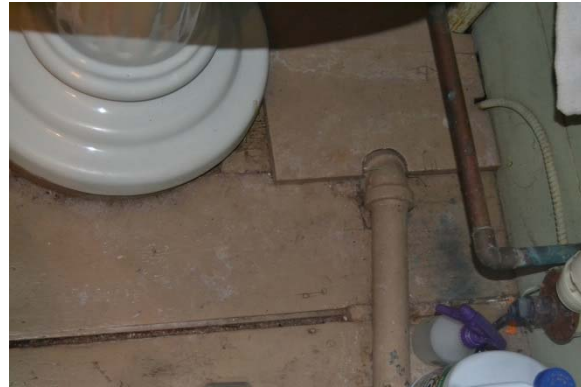
Condition: Fair, the floor and the joints between boards are quite worn and there is a plywood patch in the northeast corner where plumbing pipes penetrate the floor.

Photo 53: Condition of the floor next to the sink.

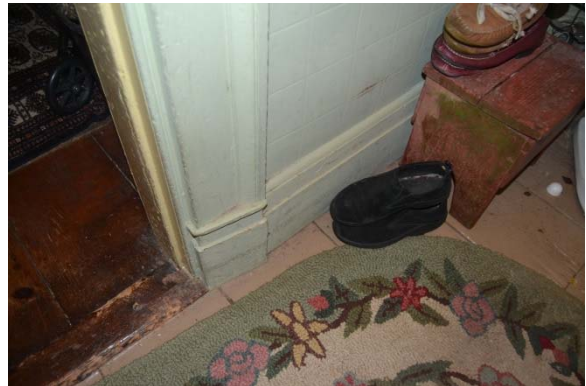
Photo 55: View of the baseboard with cap removed and replaced by a small quarter-round.

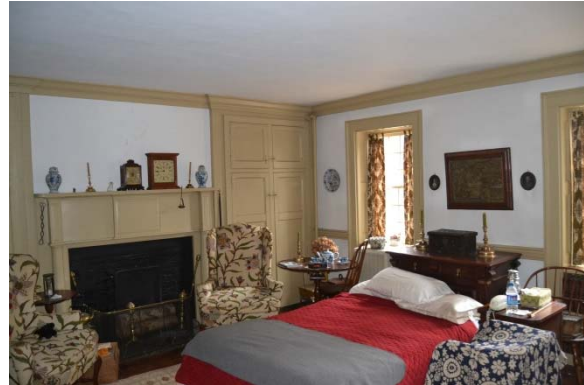
**Photo 56: View northwest. The cupboards on either side of the fireplace are not original and do not appear in the HABS documentation.**

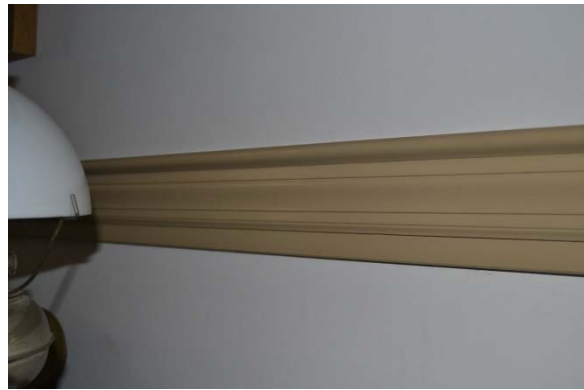
**Photo 60: Close-up of the chair rail, which was added by the current owner.**

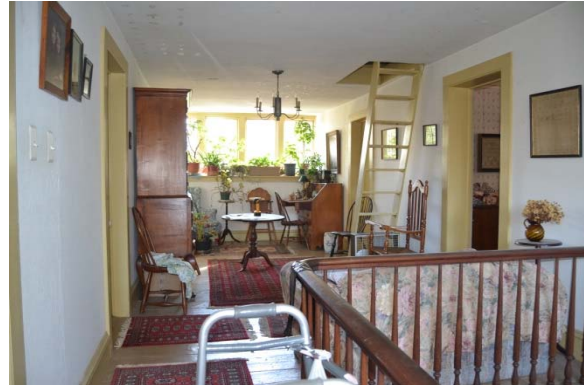
Condition: Generally good with the west wall in fair condition. The north, south and east walls have a total of about 25 l.f. of cracking and the west wall has about that much by itself. There is also a fair amount of rough plaster and patching at this wall.

**Photo 67: View south in the second floor stair hall. The ladder to the attic is visible at right.**

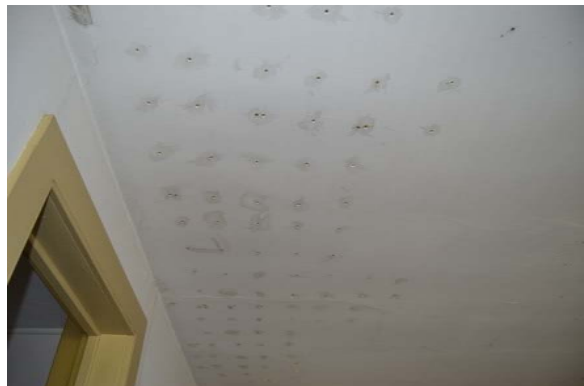
**Photo 69: View of the ceiling showing unfinished epoxy ports for attachment of plaster to lath. This was done by the current owner.**

Condition: Fair. The epoxy repairs appear to have been effective, but the areas of repair need to be skim coated and the ceiling finished.

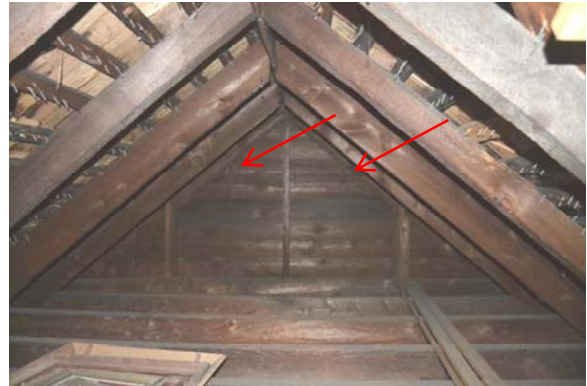
being hung sash that raise up into the dormer gable by use of a rope and pulley system operated in the attic. The two center sash at the north were horizontal pivot sash that tilted out at the bottom; these are now fixed in place. The south sash are also painted shut.

Condition: Fair. The dormers are not protected by storm windows and require complete re-glazing.

**Photo 70:** A system of pulleys in the attic provide a method of raising and lowering the two center sash at the large front dormer. There is no evidence that this system was operated from the second floor.

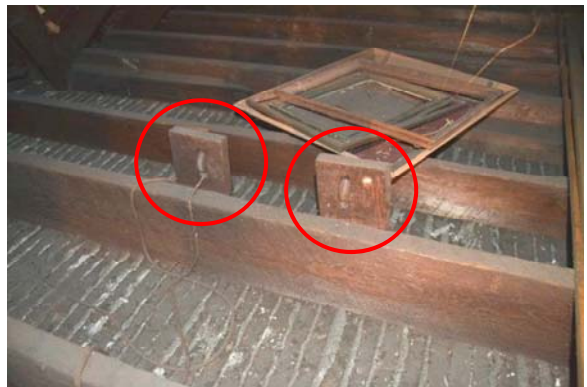
**Photo 71:** Two additional pulleys used to raise the center sash at the south dormer.

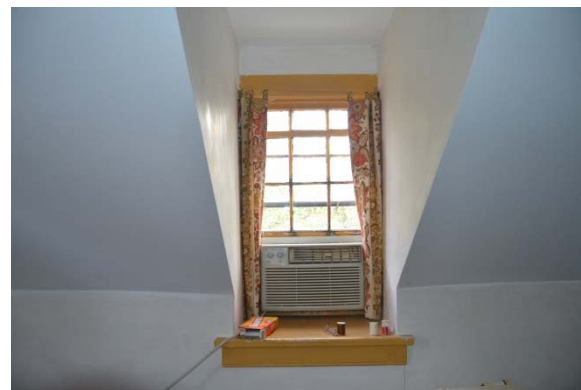
Photo 75: Interior view of the south dormer.

Condition: The condition of both windows is fair to poor. Both windows require full restoration and reglazing.

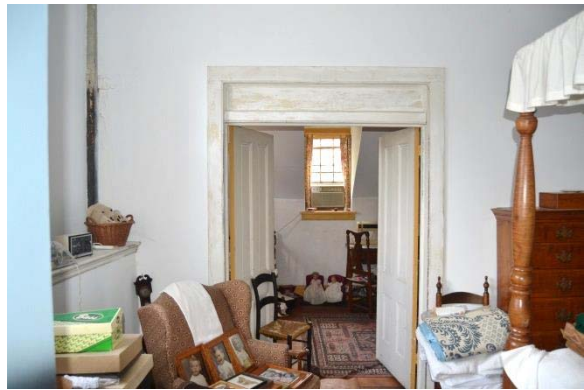
**Photo 78: View south showing the double door to Room 203.**

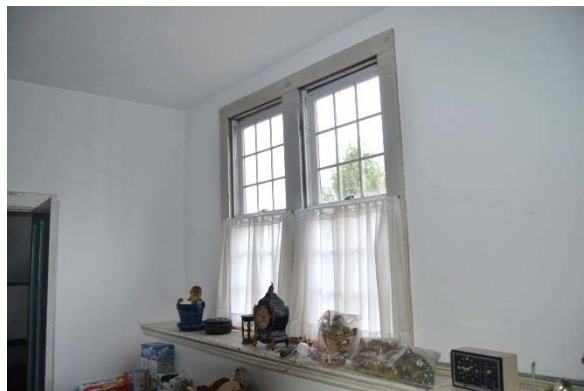
**Photo 79: The paired window at the east gambrel end.**

Windows: There is a paired window centered on the east gambrel. The window openings are historic, but not original, and they currently contain vinyl replacement sash installed within the historic opening.

Condition: The window sash are not high-quality and they are in poor condition and do not close properly.

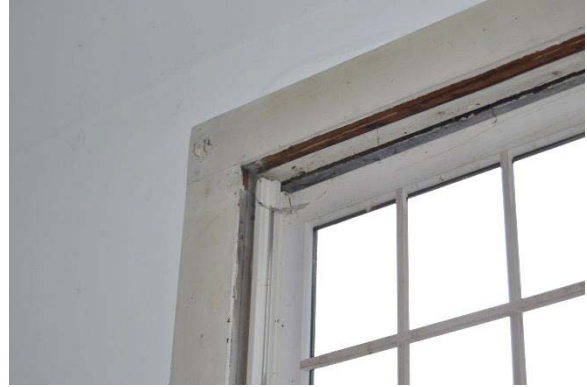
**Photo 80:** Close-up view of the window showing the replacement vinyl sash, the installation of which is poorly executed.

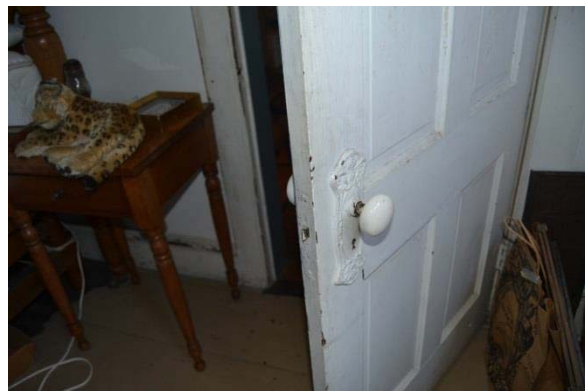
**Photo 81:** Detail of the door to Room 205. Note the door panel is different than is typical at the second floor. This door has a slight raised panel and a panel moulding that is integral to the stiles and rails.

Doors: Unlike the other doors at the second floor, the doors into this room have a slightly raised panel and an integral panel moulding rather than the applied Victorian panel moulding we see elsewhere. The hardware

appears to be early twentieth century hardware with decorative escutcheons at the knobs.

Condition: Both doors are in good condition.

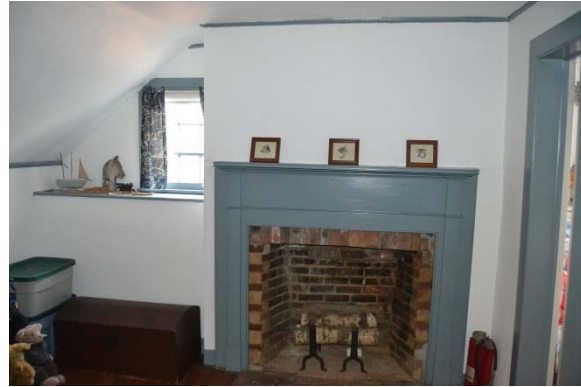
**Photo 82: View east showing the fireplace and window at this end of the room. The small crown moulding is also present in the HABS photo.**

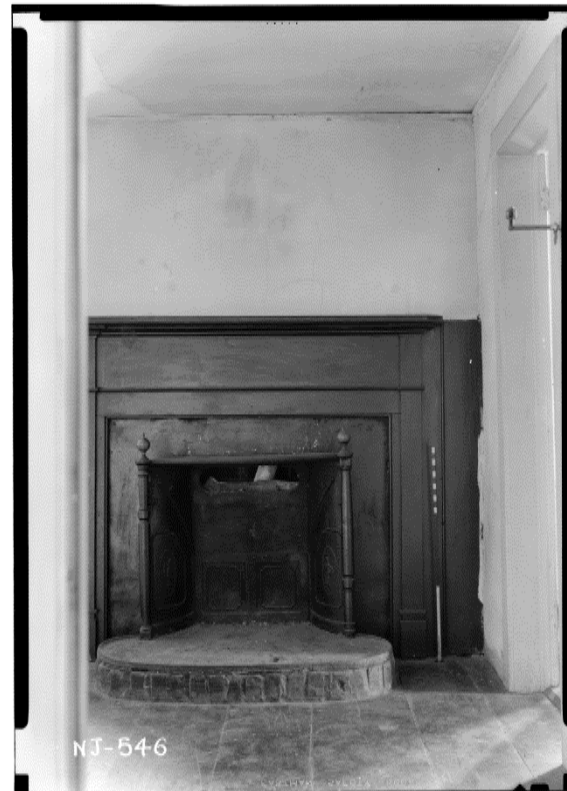
**Photo 83: HABS photograph of the fireplace in Room 205. Note the addition of a raised hearth to accommodate the Franklin stove insert.**

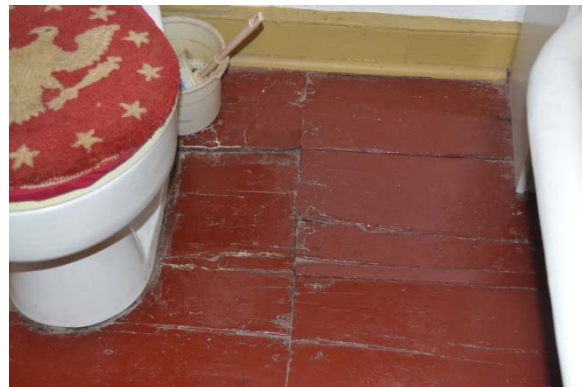
Condition: The floor is mostly in good condition, with the exception of the area around the toilet, which is poor condition.

Photo 88: Area of damaged flooring around toilet in Room 206.

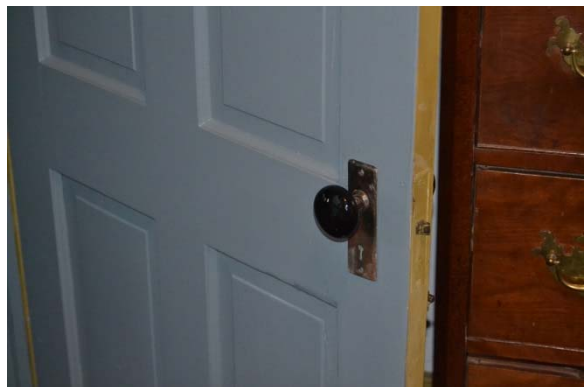
Condition: Both doors are in good condition.

**Photo 90: Close-up of door from bathroom to Room 205.**

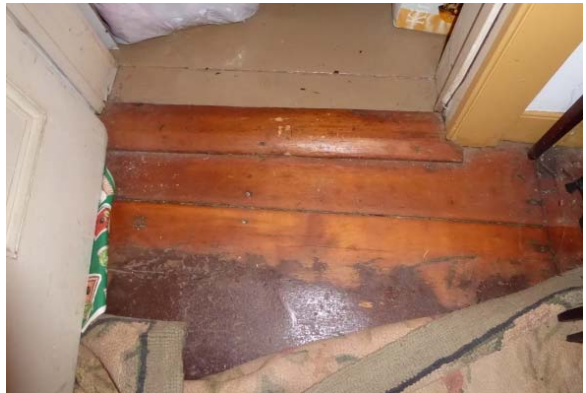
**Photo 95:** Wide board wood flooring with transparent and painted finishes.

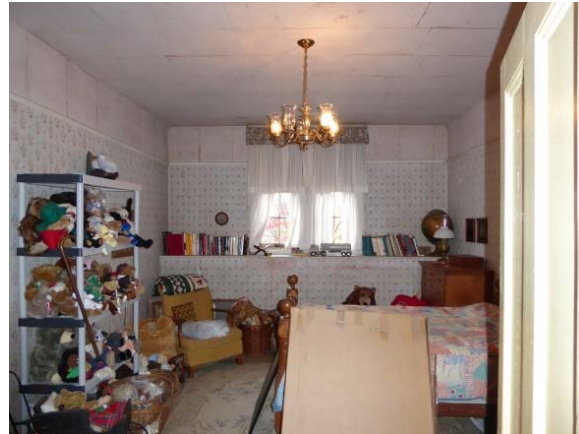
Photo 96: View into Room 208 looking west toward windows.

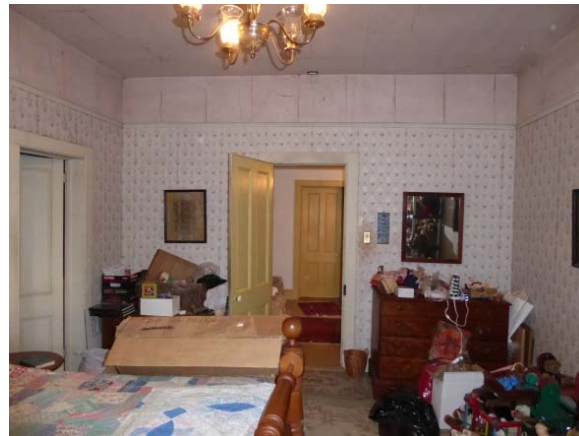
Condition: Fair. There is a crack in the upper right panel.

Photo 97: Door looking east toward stair hall.

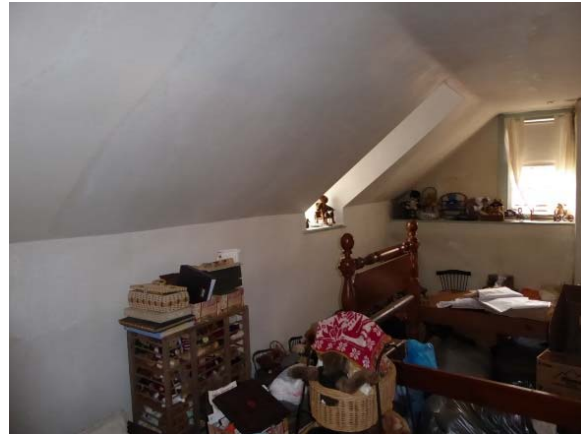
**Photo 101: View of south and west walls. Dormer window at center.**

Condition: Fair to poor. There are no sash cords on either window. Both windows have peeling paint and rotting wood.

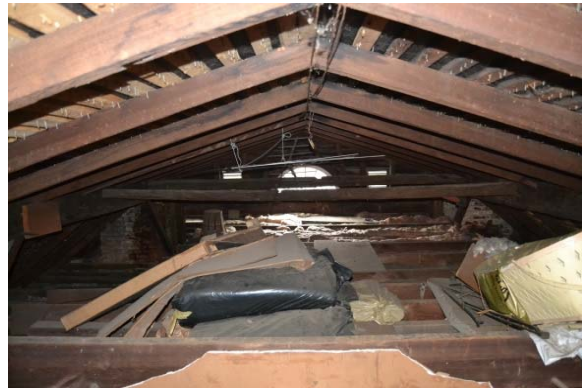
Condition: The condition of the framing generally appears good, although there is evidence of water damage around the chimneys, but it is not clear if this is a result of active leaks.

**Photo 106: View towards east gambrel end. Water damage to wood is visible.**

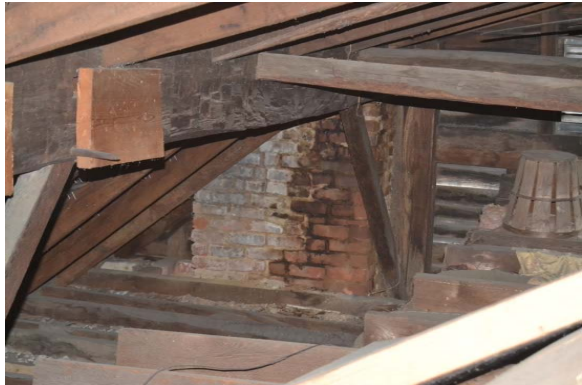
**Photo 107: View of the northeast chimney. Note the water staining. It is not known if this leaking is active, but the flashing at the exterior and the roof appear sound.**

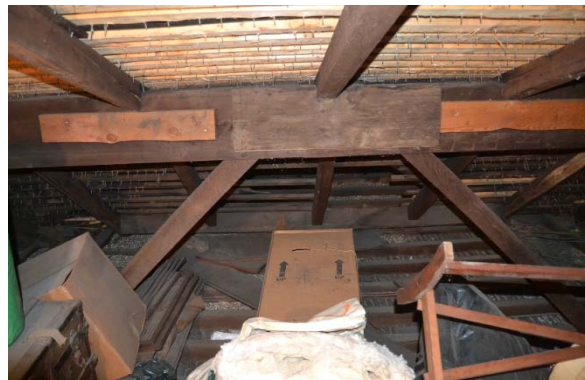
**Photo 110:** View of the joint of the two sections of purlin on the north side of the attic. The section of purlin to the right is hewn and that on the left is sawn, however this does not appear to be related to the roof being built in two sections.

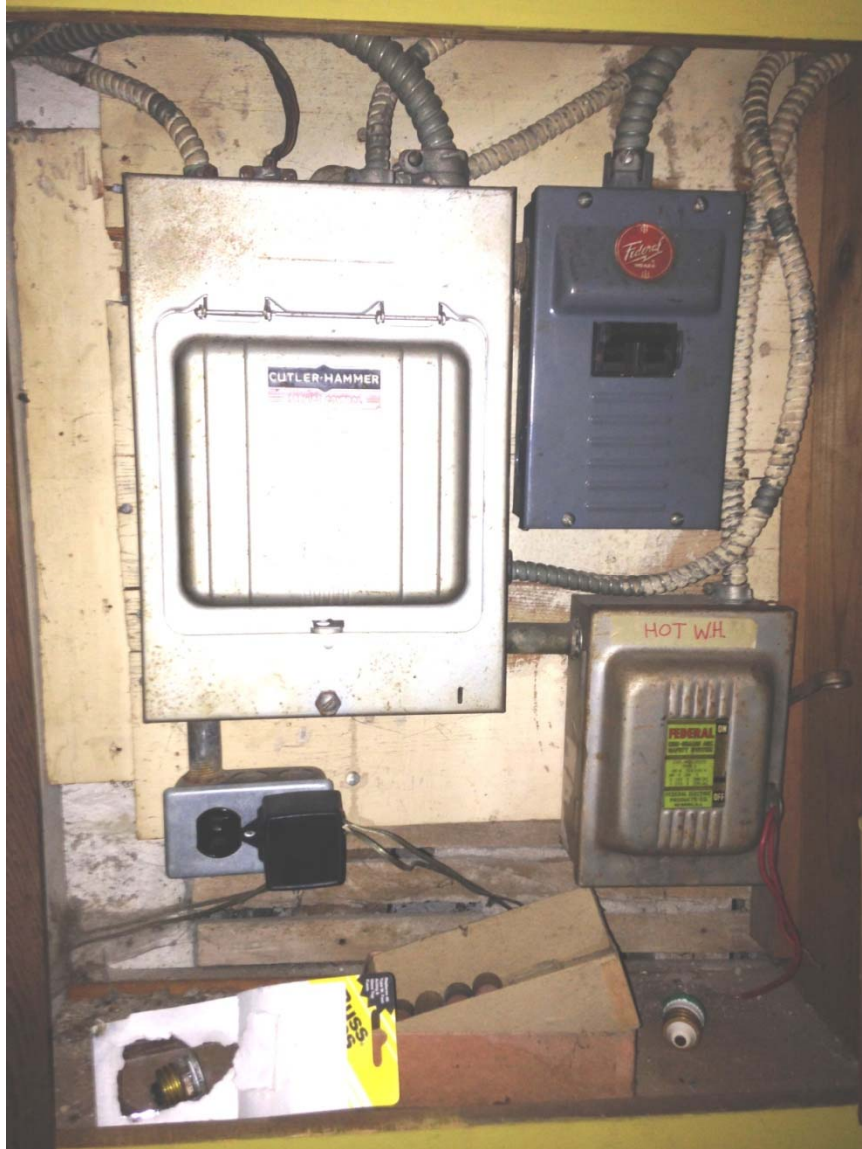
MAIN ELECTRIC FUSE PANEL AND SUB-FEED FUSES

1. The electrical panels and disconnects should be replaced with new circuit breaker panels.
2. The wiring throughout should be tested for proper grounding and insulation resistance.
3. New receptacles should be added as required for the proposed program and use.
4. A service upgrade will be required to support the air conditioning equipment.
5. Fluorescent and incandescent fixtures should be replaced with LED.
6. The security and fire alarm systems should be removed and replaced with new. Smoke detectors should be installed on all levels.
